BMC 'A' Series engine roller rocker valve gear modifications – and potential problems!

Hylton Reid describes how the 'roller rocker' valve gear system he fitted to his Austin A30 (powered by a 1098cc 'A' Series engine) resulted in unforeseen difficulties that stopped the engine dead, when on a journey...

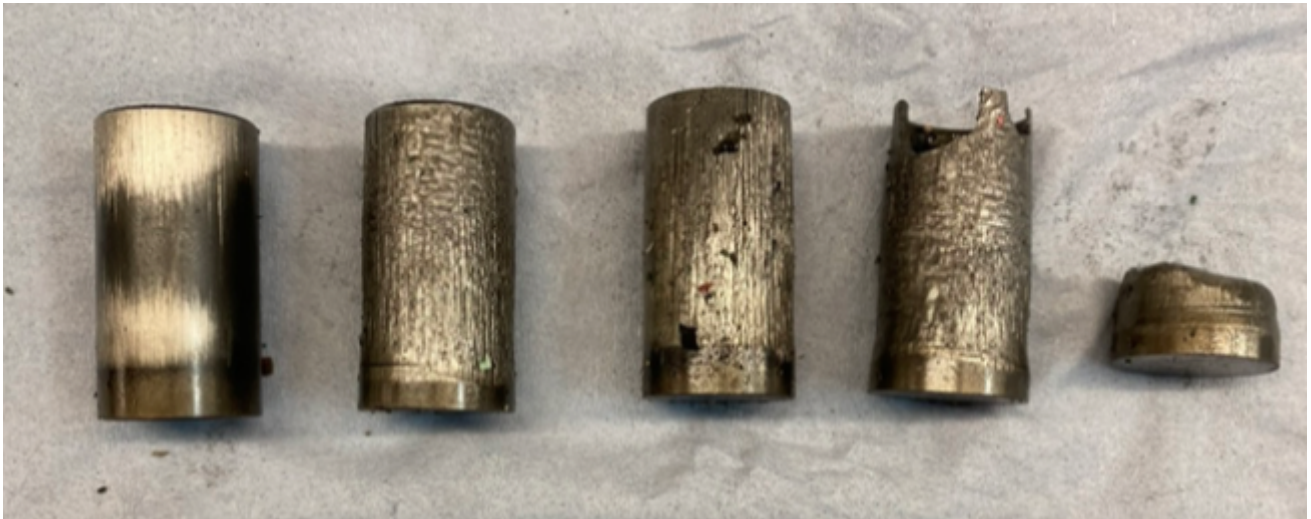
Ouch! Cam followers showing varying degrees of damage, as explained in the text by Hylton Reid.

Unfortunately, in my case, there was an unidentified high spot in the head casting which was rubbing on number 1 pushrod. This caused metal filings to fall down into number 1 tappet, and also into numbers 2, 3 and 4.

The heading picture shows the front 4 tappets, as removed from my engine. From left to right, the first one is from No. 4 and can be seen to be in reasonable condition, whereas the second is severely scored, the third is even more severely scored and has failed at the top.

The last one has virtually disappeared. This was the one that fell into the block, jamming the camshaft lobe and shearing off the camshaft drive. This stopped the engine!

Obviously, the bores in the block would also be severely scored, so just fitting new tappets would be a waste of time. The answer would be to find a replacement block. These are now becoming very hard to find for the 10CC (1098cc) engine, although 1275cc blocks can be located.

The solution was offered to me by Keith Calver of Calver ST in Malton, North Yorkshire - 'A' Series specialists (<https://www.calverst.com/>). The block needs to be re-bored slightly oversize and larger tappets fitted. The ones he suggested came from a Hillman Hunter. The only firm in the UK who could undertake the machining of the block were Damico Engines of Norwich (engine performance specialists: <https://www.damico-engines.co.uk/>), because the tappet bores are not fully vertical but are angled at 2.5 degrees!

Now that this work has been completed I have checked the clearance around the pushrod holes in the cylinder head. That is when I found the casting irregularity. The solution was to drill out all of the pushrod holes to a slightly larger diameter. Every one of them was not a “clean” hole and needed to be tidied up.
