BMC 'A' Series engine roller rocker valve gear modifications – and potential problems!

Hylton Reid describes how the 'roller rocker' valvegear system he fitted to his Austin A30 (powered by a 1098cc 'A' Series engine) resulted in unforeseen difficulties that stopped the engine dead, when on a journey...

An alternative title, in Hylton's own words, "The disaster of fitting roller rockers to an 'A' Series engine"!

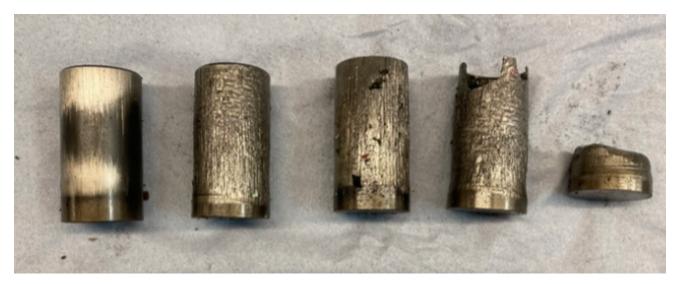
Ouch! Cam followers showing varying degrees of damage, as explained in the text by Hylton Reid.

Unfortunately, in my case, there was an unidentified high spot in the head casting which was rubbing on number 1 pushrod. This caused metal filings to fall down into number 1 tappet, and also into numbers 2, 3 and 4.

The heading picture shows the front 4 tappets, as removed from my engine. From left to right, the first one is from No. 4 and can be seen to be in reasonable condition, whereas the second is severely scored, the third is even more severely scored and has failed at the top.

The last one has virtually disappeared. This was the one that fell into the block, jamming the camshaft lobe and shearing off the camshaft drive. This stopped the engine!

Obviously, the bores in the block would also be severely scored, so just fitting new tappets would be a waste of time. The answer would be to find a replacement block. These are now becoming very hard to find for the 10CC (1098cc) engine, although 1275cc blocks can be located.

The solution was offered to me by Keith Calver of Calver ST in Malton, North Yorkshire - 'A' Series specialists (https://www.calverst.com/). The block needs to be re-bored slightly oversize and larger tappets fitted. The ones he suggested came from a Hillman Hunter. The only firm in the UK who could undertake the machining of the block were Damico Engines of Norwich (engine performance specialists: https://www.damico-engines.co.uk/), because the tappet bores are not fully vertical but are angled at 2.5 degrees!

Now that this work has been completed I have checked the clearance around the pushrod holes in the cylinder head. That is when I found the casting irregularity. The solution was to drill out all of the pushrod holes to a slightly larger diameter. Every one of them was not a "clean" hole and needed to be tidied up.
