## Classic Mini Tech – early Mini differential output oil seal leak fix – but is the seal the culprit?

Published: July 30, 2026

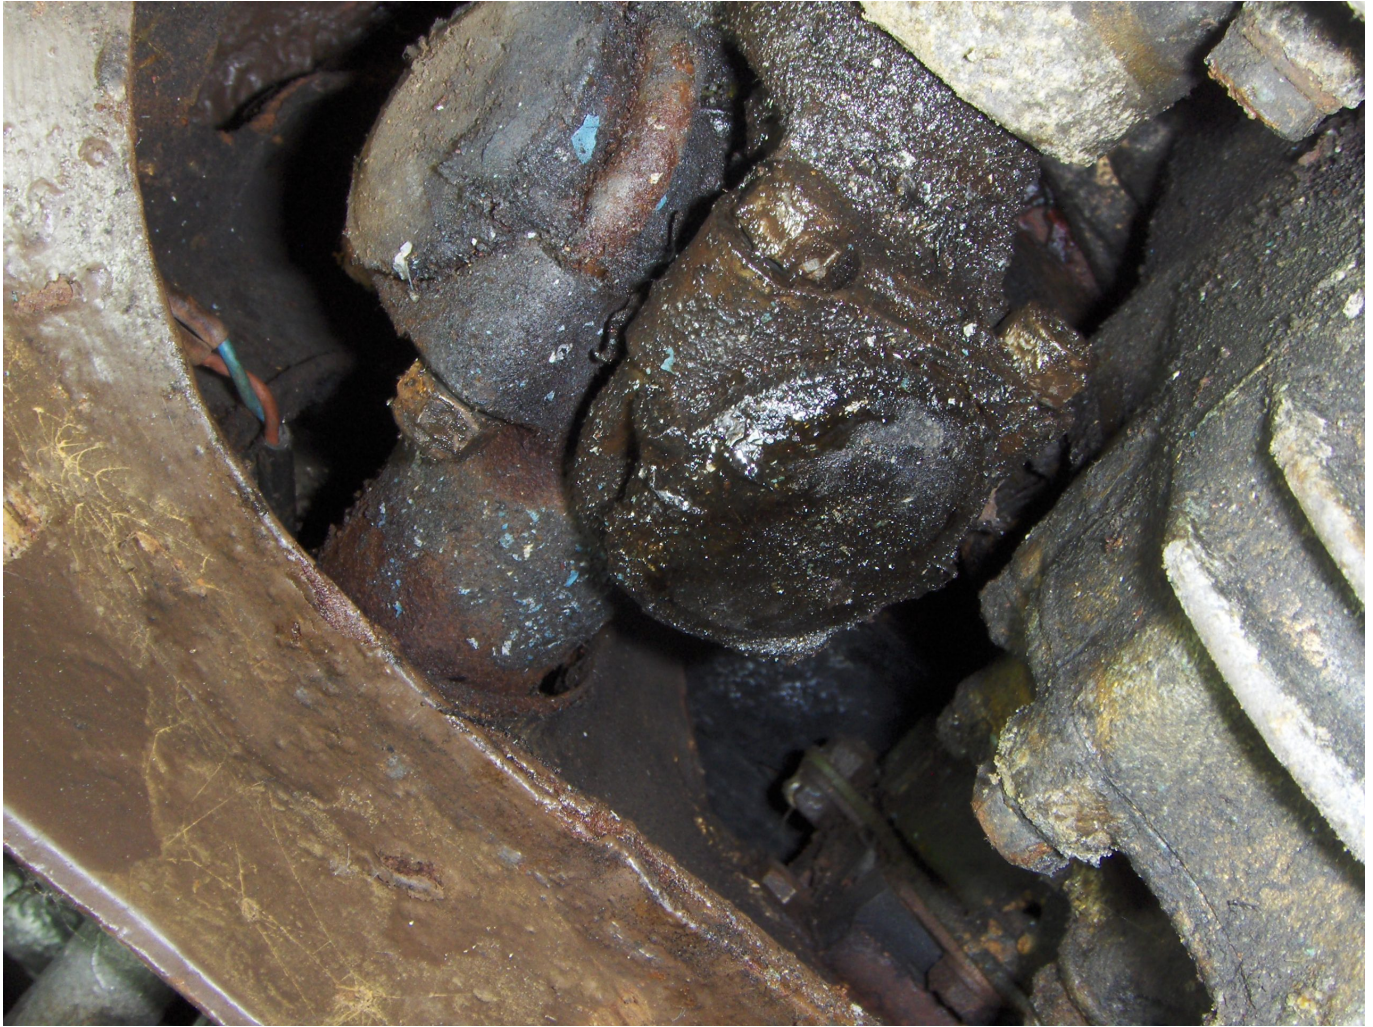
Oil bound inner UJ/doughnut connected to driving flange before dismantling.

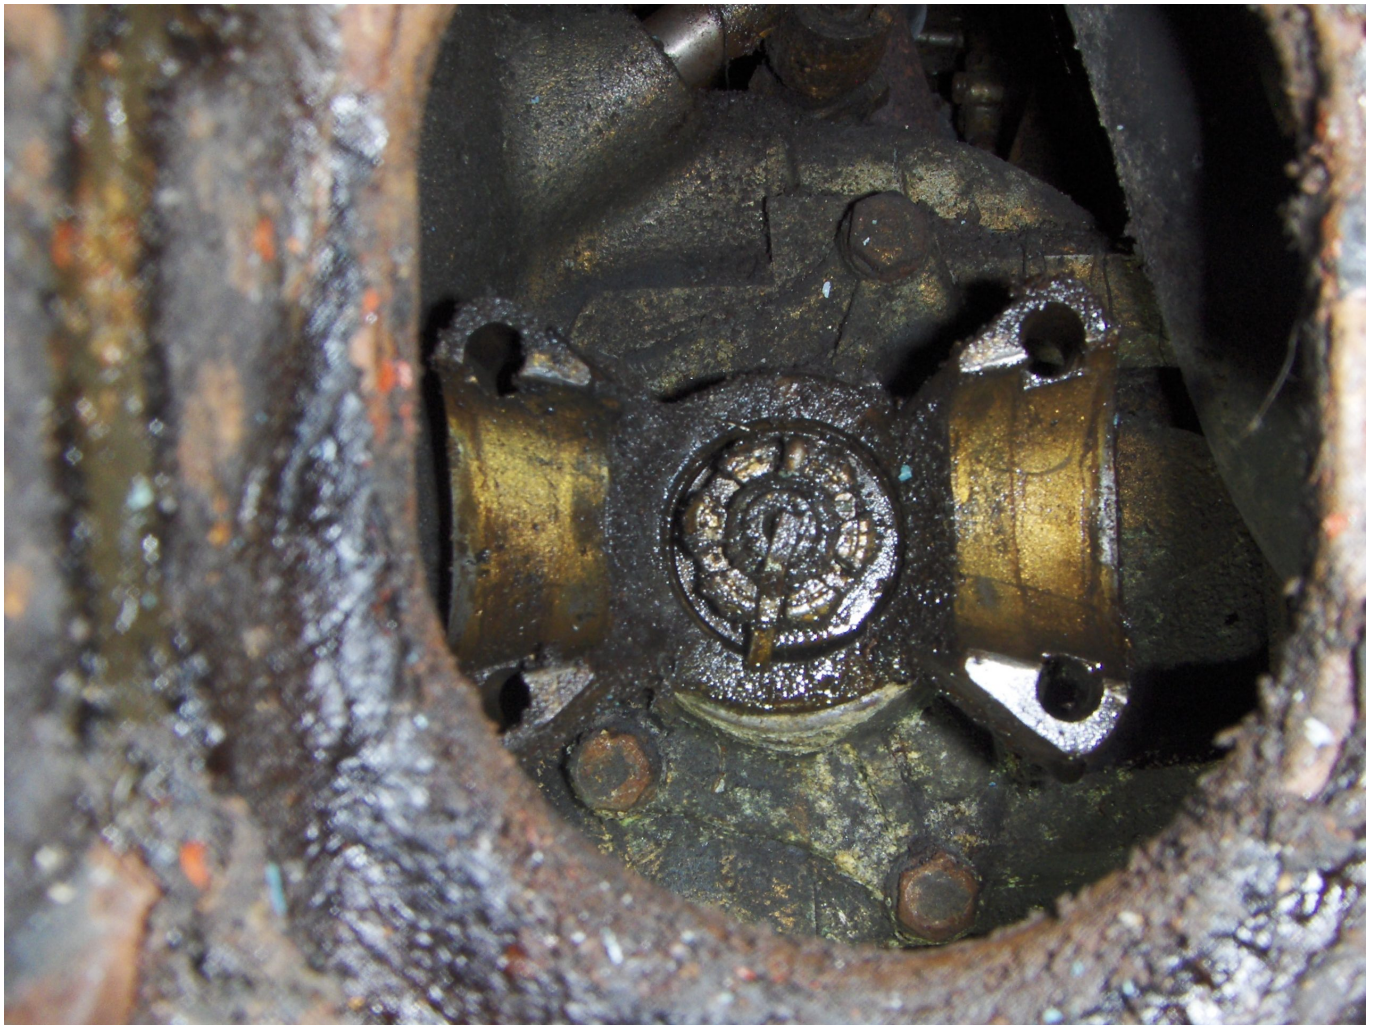
The next step is draining the engine/transmission oil, but I didn't quite get that far. Removing the de-greaser residue, up close, with now spotlessly clean components fully illuminated, it was clear... the oil seal wasn't leaking. Surprisingly, oil was very slowly, but definitely, weeping out from behind the driving flange securing nut. With daunting thoughts of sourcing obscure differential components for a car built 66 years ago, in a series known to have had at least four different transmission part numbers in its first year - I reached up to gauge flange spline wear through movement... and, observing closely, bizarrely the

revealed movement suggested the nut itself appeared loose - and, sure enough, it was not even finger tight - against a 70lb/ft workshop manual torque figure! This transmission is a complete BMC Gold Seal unit, service-exchanged at a main dealer in 1969, which had run reliably without any attention until the slight oil leak, which started in 2023.

Differential driving flange as first viewed through the drive shaft subframe hole.

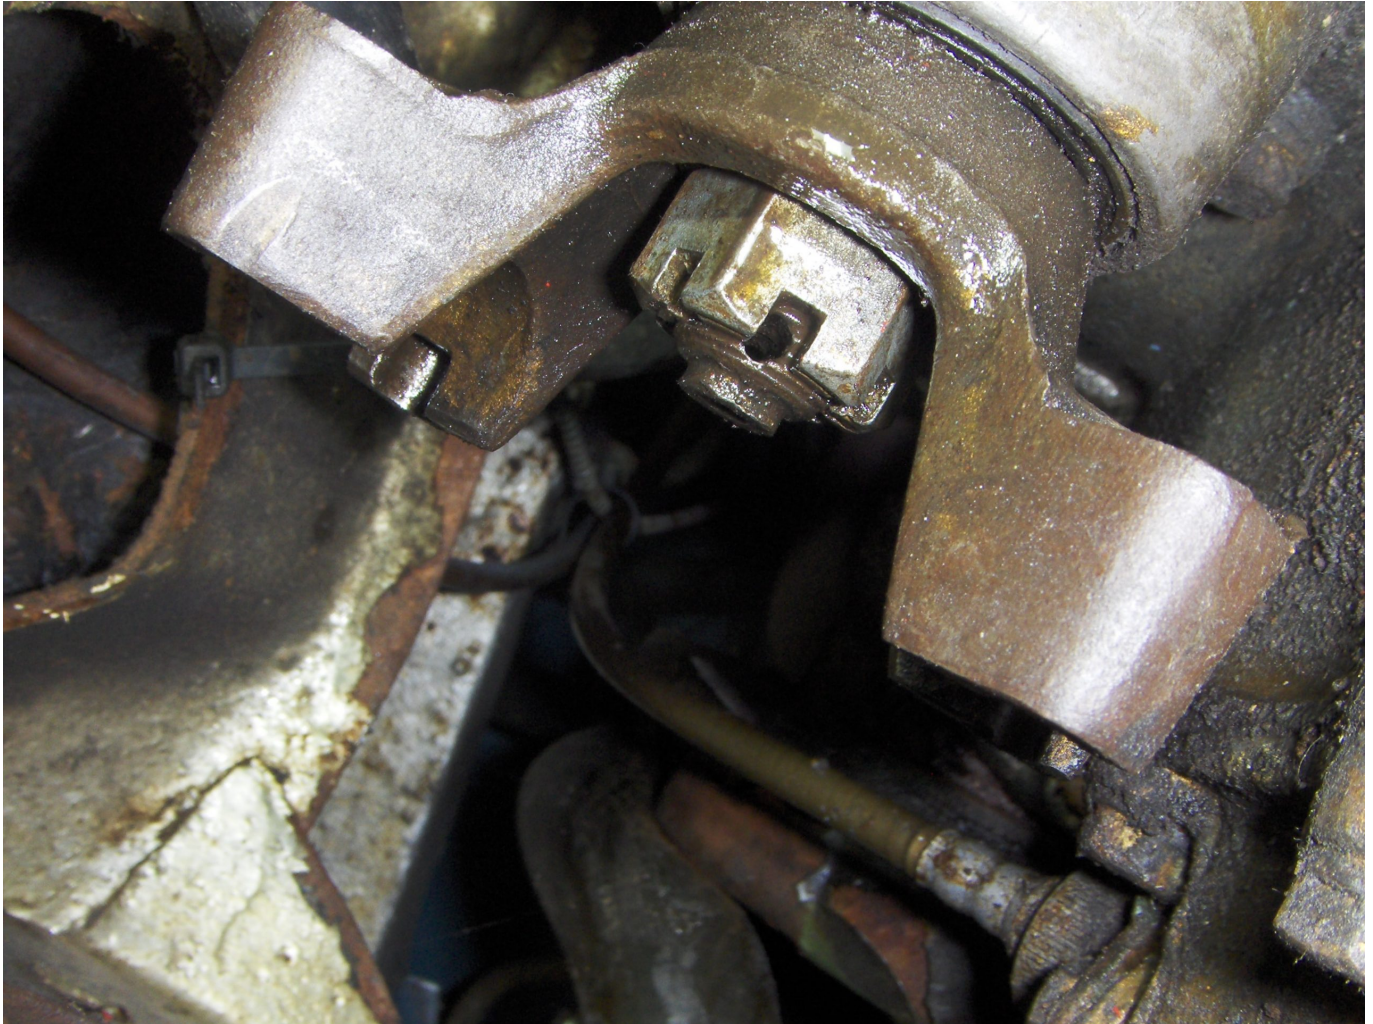
Underneath view of cleaned up driving flange. Traces of Gold Seal paint still visible... Note split pin hole not aligned (not even finger tight), and gap between nut and washer can be clearly seen).

With securing split pin removed, quickly tightening the nut with a ring spanner before lunch had completely stopped weepage afterwards, so I started making the special tool needed to achieve recommended torque on the nut with some confidence. The problem, with the transmission in place, is simple: Somehow, underneath the car, in a confined space, the drive flange must be securely prevented from turning - while still allowing access for a 15/16 inch AF socket to tighten the flange nut. There was a steel BMC tool, part no 18G669, for this job, but it can be achieved by fabricating something suitable from a sturdy piece of timber. (See separate section)

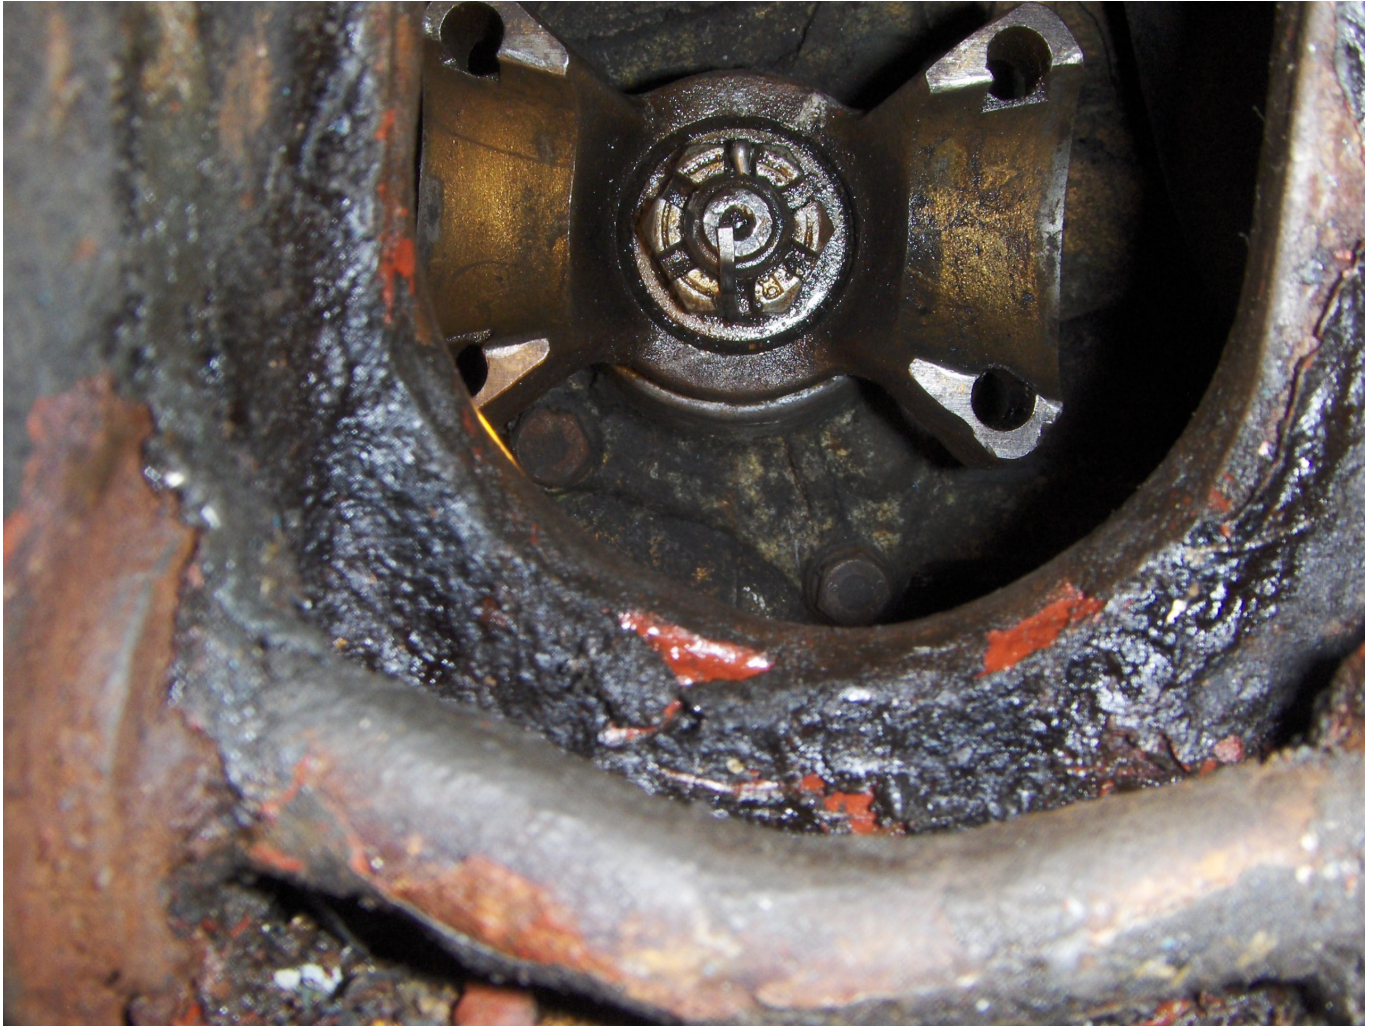
Drive flange bolt tightened to 70lb ft and new split pin inserted. No sign of leaks!

Driving flange locknut – tighten to 70lb/ft and increase to align the castellated nut with the next split pin hole.

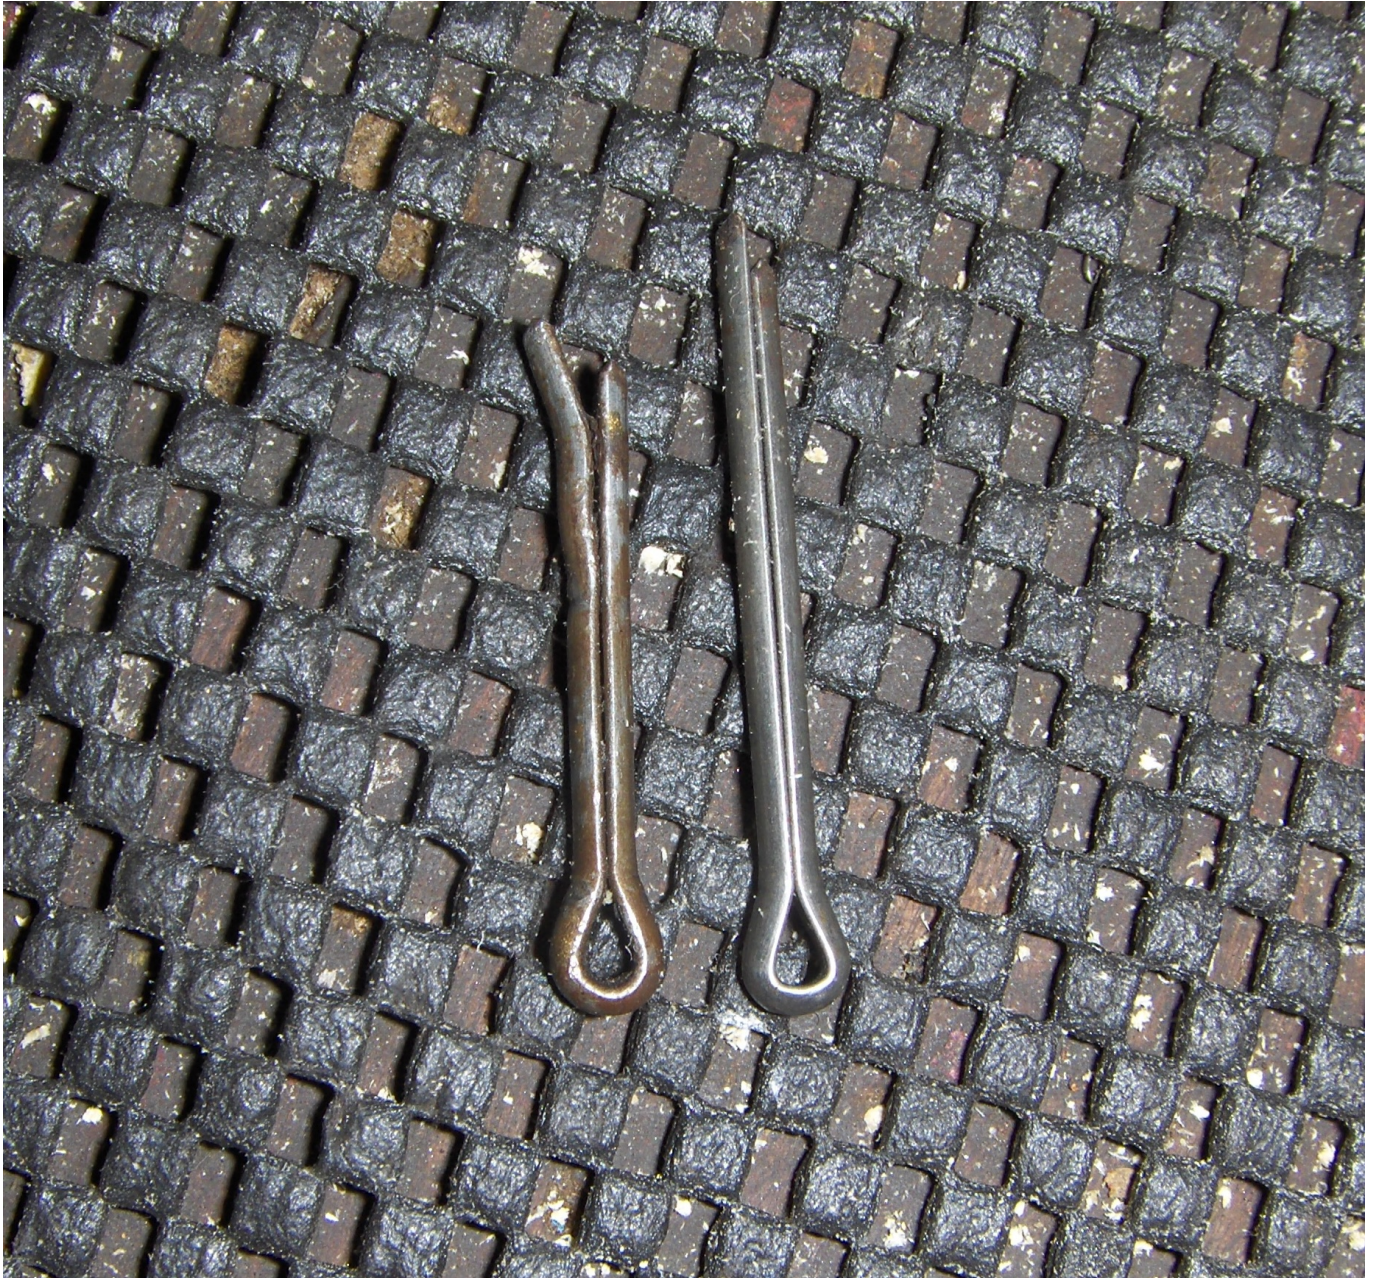
ALWAYS use a new split pin on re-assembly. Here's the old split pin (from the drive flange retaining nut) on left, no obvious damage, new on right.

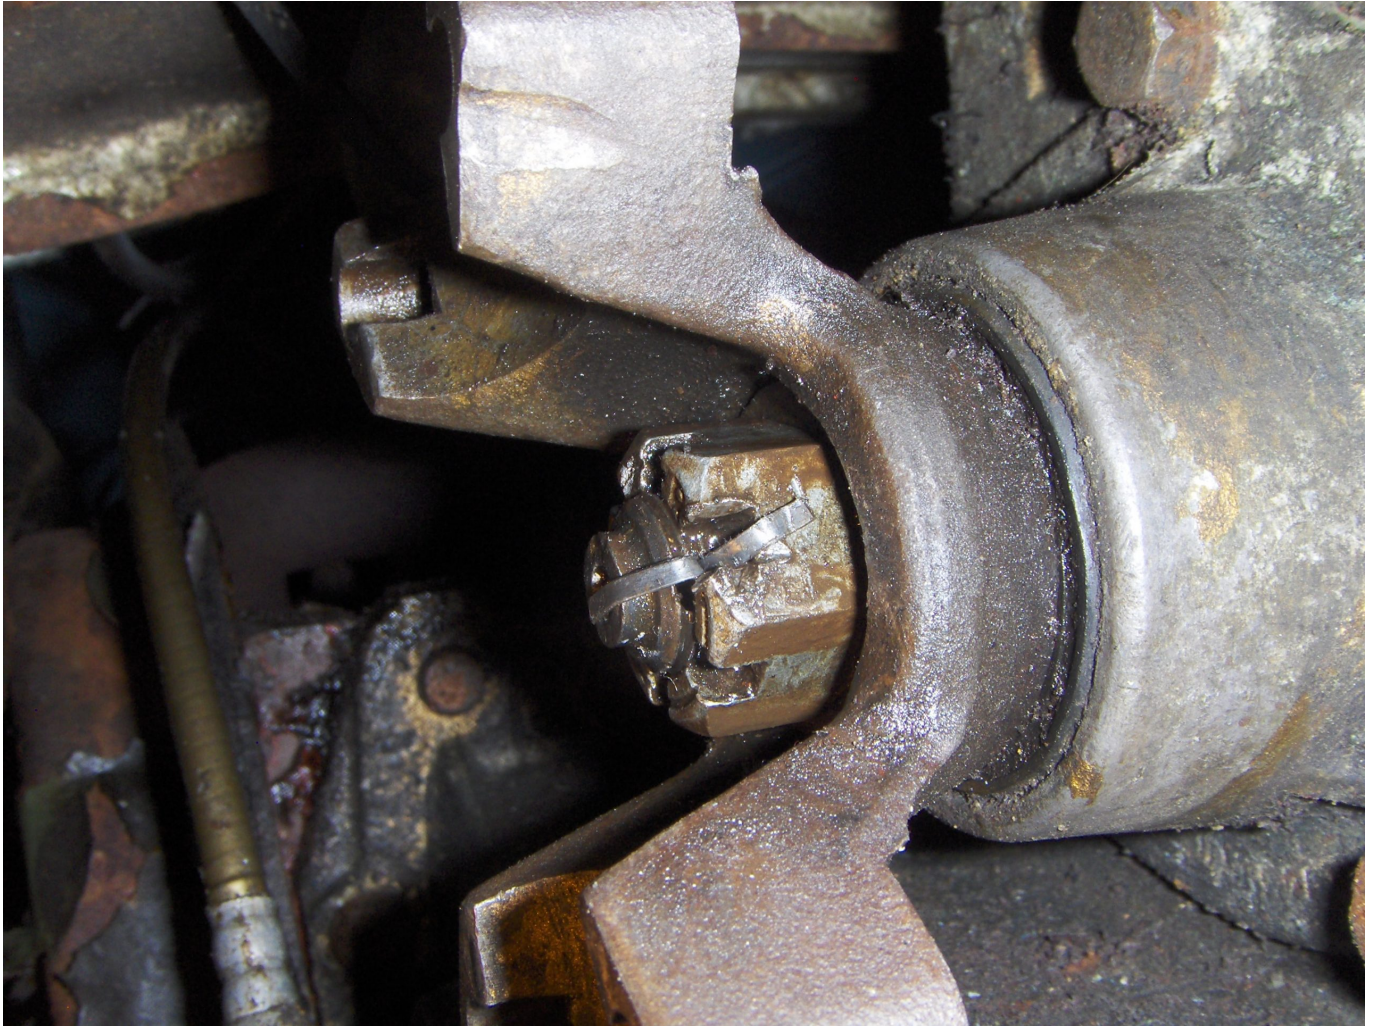
This is the cleaned up output flange, with the retaining nut tightened and the split pin inserted- no sign of oil leak around seal radius on right.

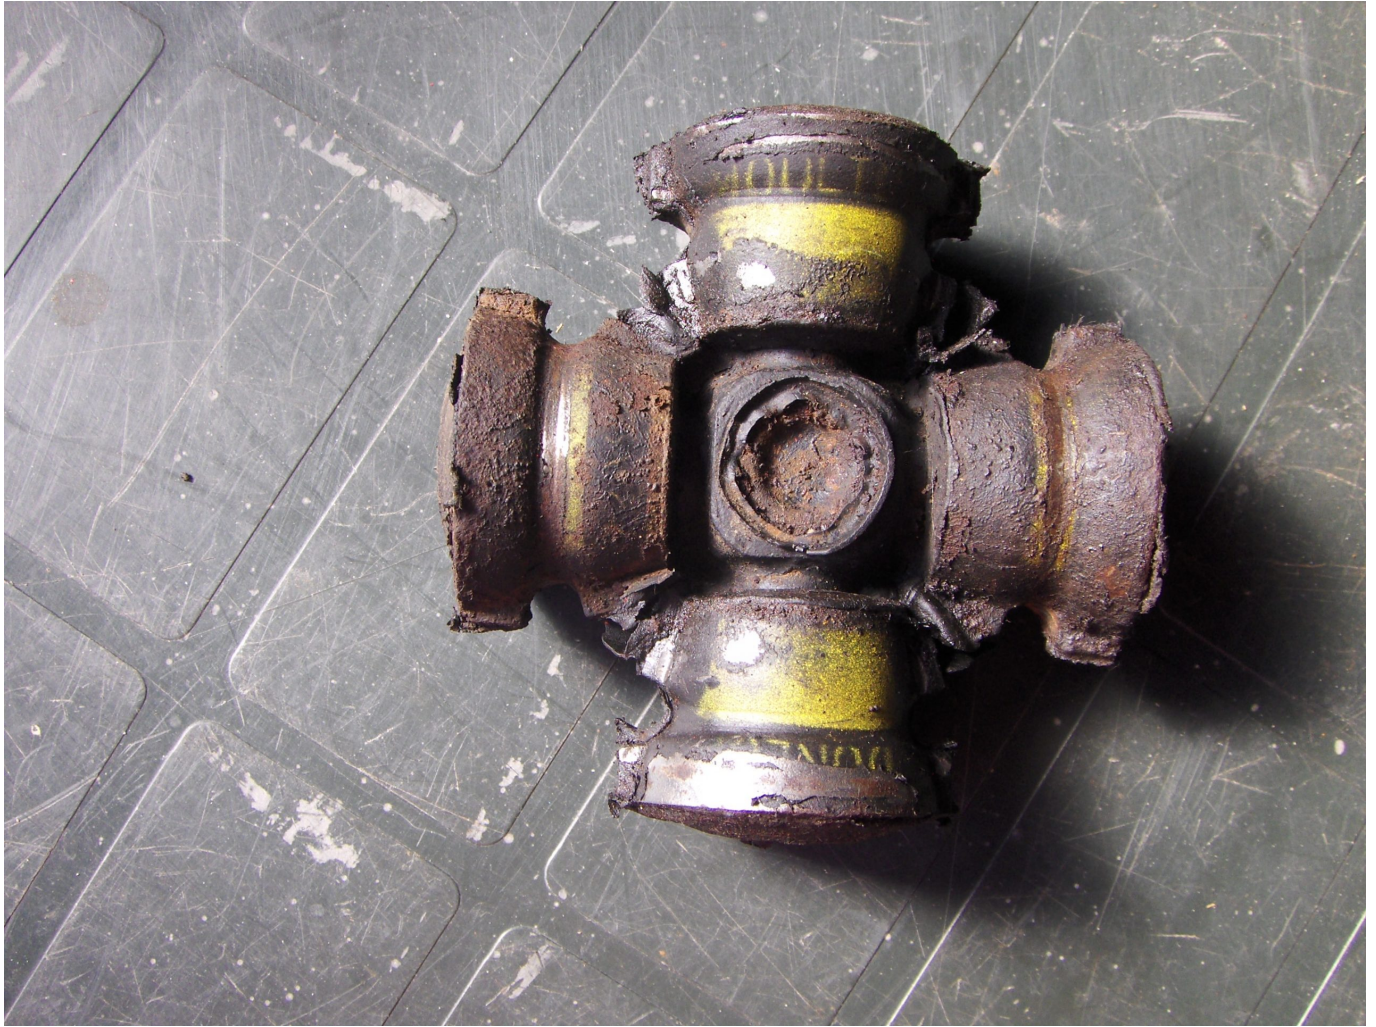
Cleaned up doughnut - early style but still in good condition. (Made by Dunlop).

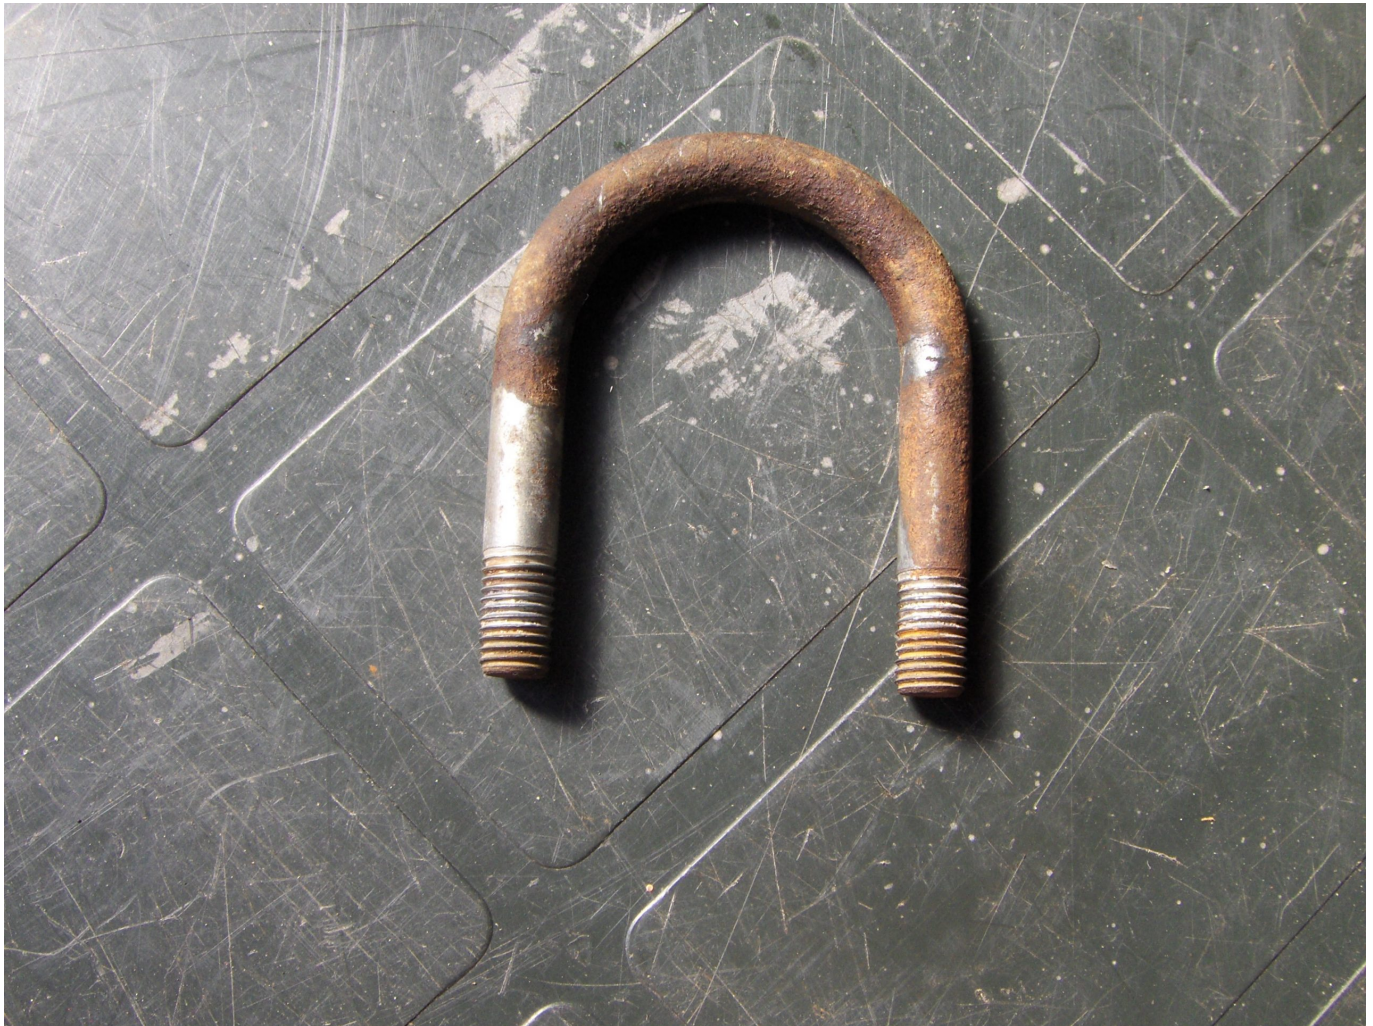
Cleaned U bolt, note shine midway along in rust on both sides indicating wear point.

- Use new 'Nyloc' full nuts on these U bolts when reassembling. (The Workshop Manual cautions against using 'deformed thread' types – sometimes called “stiffnuts”)
- Ensure you have all required parts available before starting re-assembly. It's really irritating to have to stop work midway until parts are obtained. Don't forget tie-rod and swivel pin parts, and brake pipes/hoses/attachments.
- Check the condition of the drive shaft inner sliding joint and outer universal joint rubber boots: if either are deteriorating, cut, damaged or leaking grease, it's an MoT fail; they must be replaced.

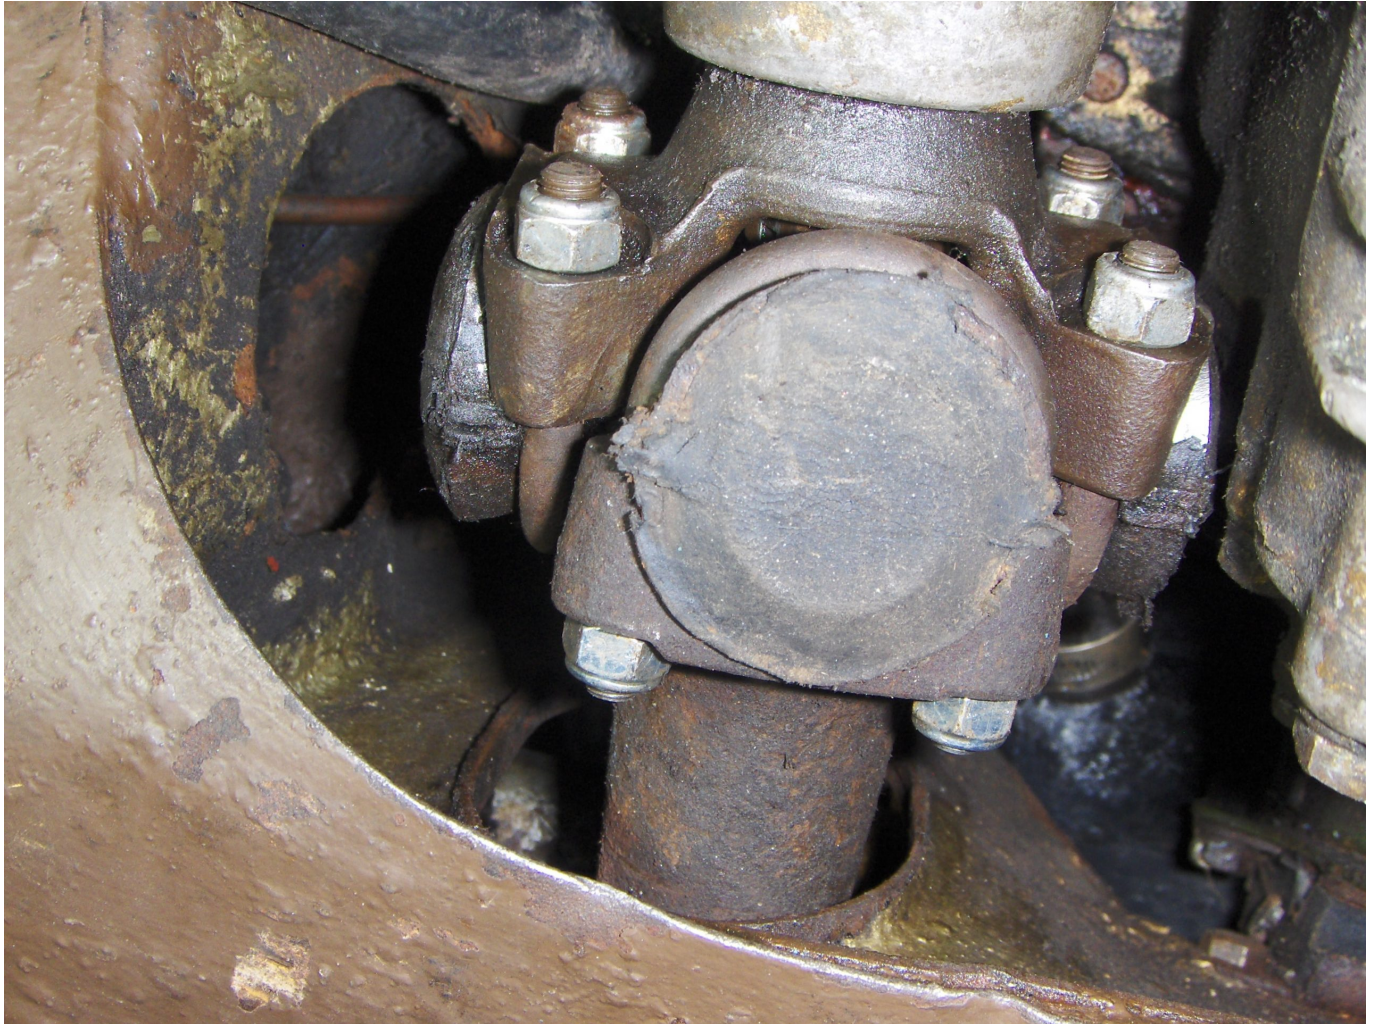
Drive shaft back, re-coupled to flange. Doughnut and U-bolts reused, new nyloc nuts.

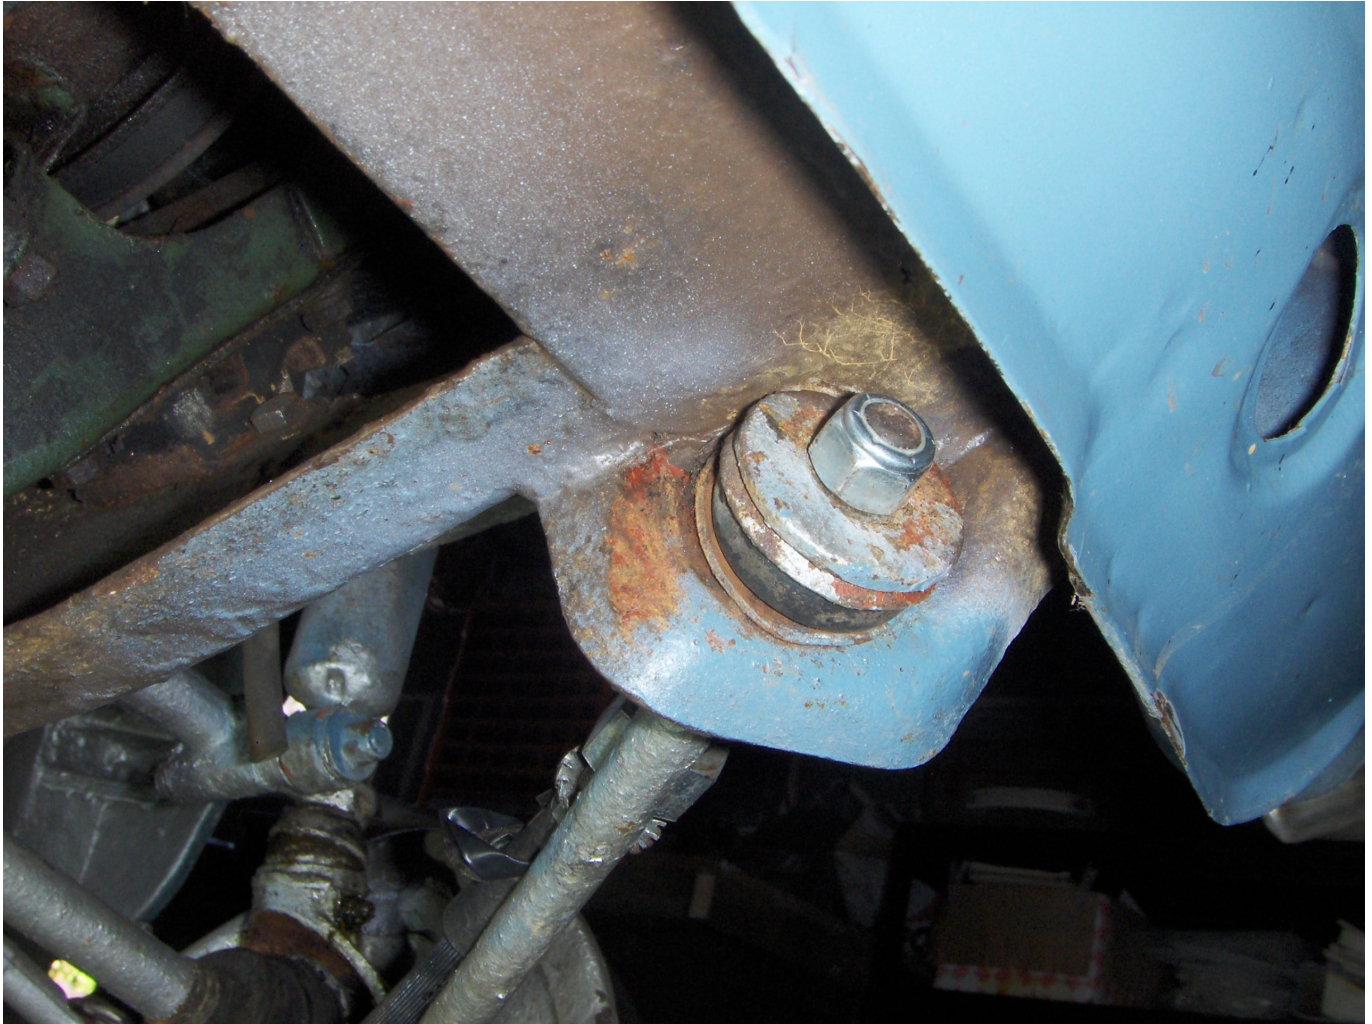
New nut and bushes sited at forward end of tie rod. Not as rusty as it looks (honest!).
