Grumpy Old Mechanic – VW design flaw that results in engine oil flowing into the alternator

Published: January 2, 2018 Author: Kim Henson Online version: https://www.wheels-alive.co.uk/grumpy-old-mechanic-vw-design-flaw-that-results-in-engine-oil-flowing-into-the-alternator/

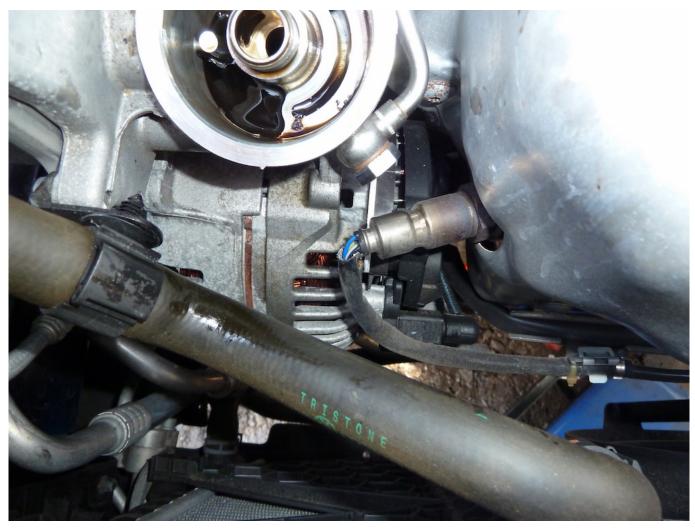
Oil filter mounted just above the alternator equals bad news...

However... One wonders who dreamt up the idea of locating the oil filter immediately above the alternator, with no shield between the two? (Our photo depicts a 2013 VW Polo 1.2, as an example). As the oil filter is released from the engine, inevitably engine oil escapes and due to gravity then runs down... and all over/into the alternator. This does the unit no good whatsoever, and indeed the presence of lubricant in quantity could write it off.

In my garage we are prepared for this design anomaly, to the extent that we place rag on top of the alternator, to catch the oil before it can do any damage.
