## Assault and Battery? – Grumpy Old Mechanic

Published: November 16, 2015

Author: Kim Henson

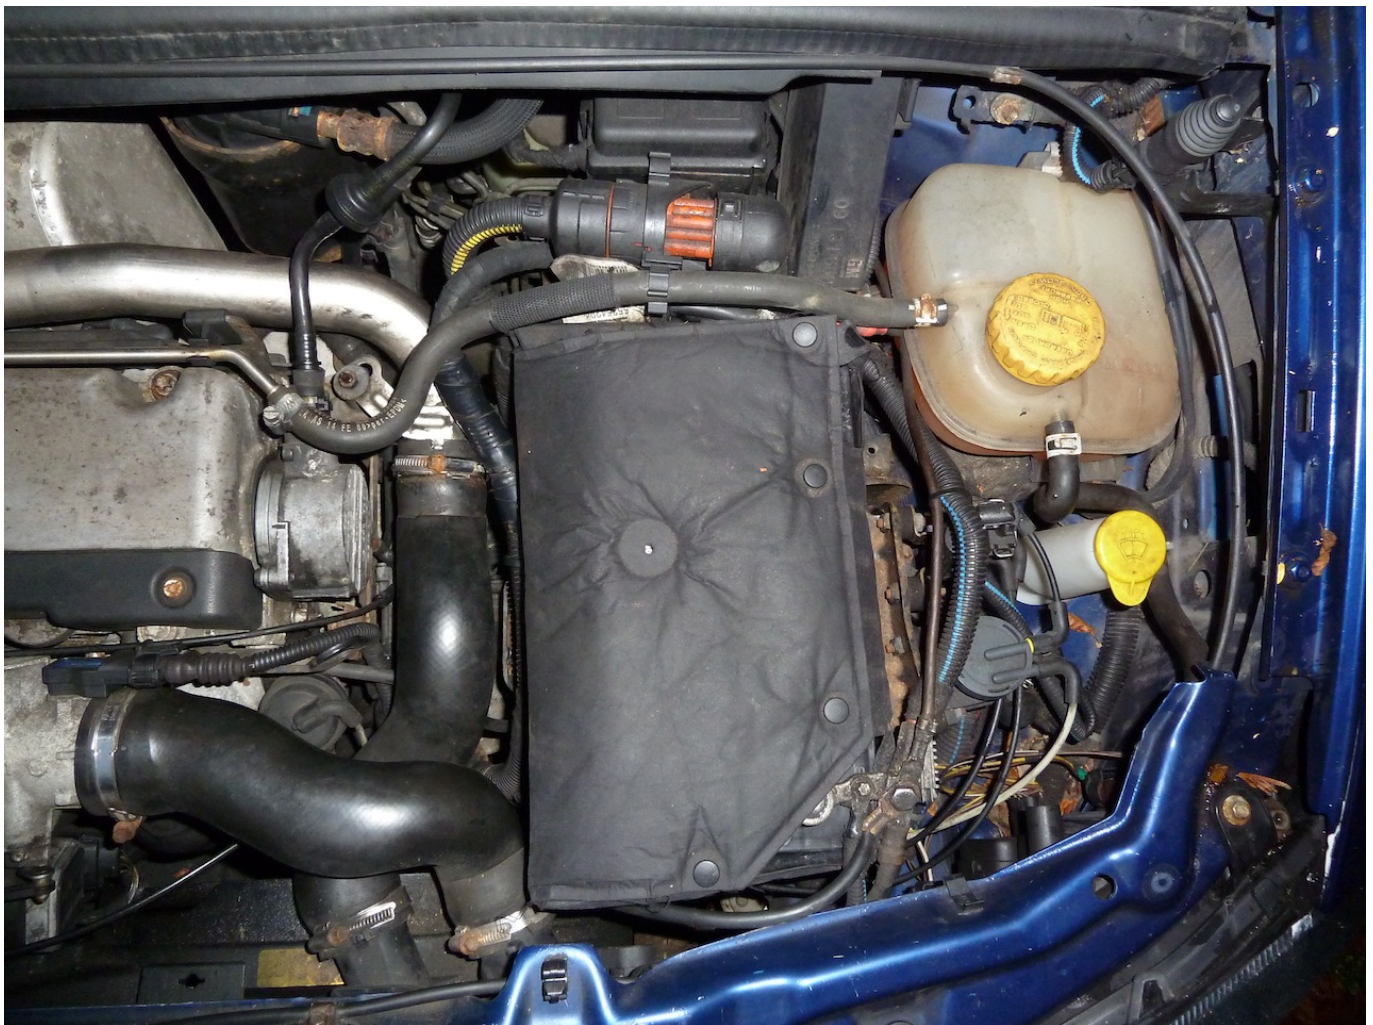
No way in? With many modern cars it's almost impossible to reach the securing clamp, when the time comes to fit a new battery.

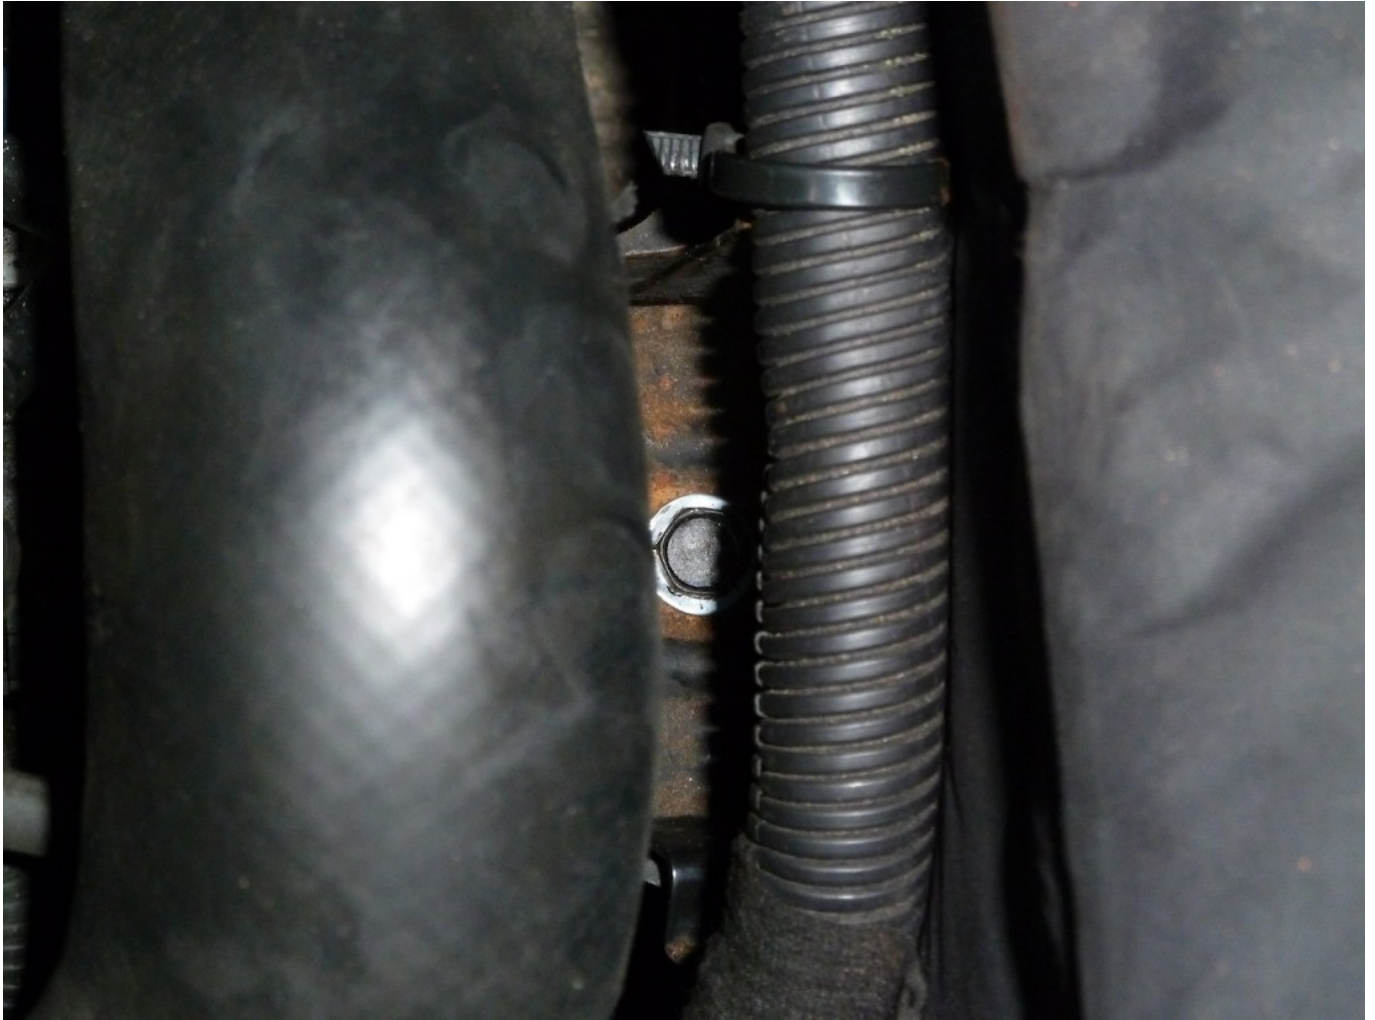
position (which would have been quite possible), it was buried in the depths of the engine compartment, amidst a maze of hoses and electrical wiring. Indeed it was almost impossible to see, let alone reach.

Our chap, who is diligent and knowledgeable, took great care to release and unscrew the bolt so that it would remain within the clamp ready for easy re-assembly. Unfortunately, due to the poor access and the bolt being too short for the job (it was an original bolt that had been in the car from new!), the bolt was disturbed as the battery was lifted out. Said bolt then disappeared into the depths of the engine bay, and, despite the best efforts of three of us, has not been seen since, so tightly packed is the engine within the bay.

Spot the bolt for the clamp securing this battery... It's only just visible, let alone reachable, even after moving hoses, wiring, etc!

We found a new metric bolt, of the same thread dimensions but a little longer than the original (to make it a bit easier to install) and then attempted to fit this, together with new lock and plain washers.

This took a very long time, even after we had moved cables and hoses (such operations also being fraught with potential problems, especially as a vehicle ages and rubber/plastic components can become brittle).

Eventually we 'won' and the battery was installed, complete with its new bolt - but what a performance for a job that should have been quick and easy... How much easier it would have been if the clamp had been mounted in a slightly different position, where it could more easily have been reached.
