Assault and Battery? – Grumpy Old Mechanic

Published: 16th November 2015

Author: Kim Henson

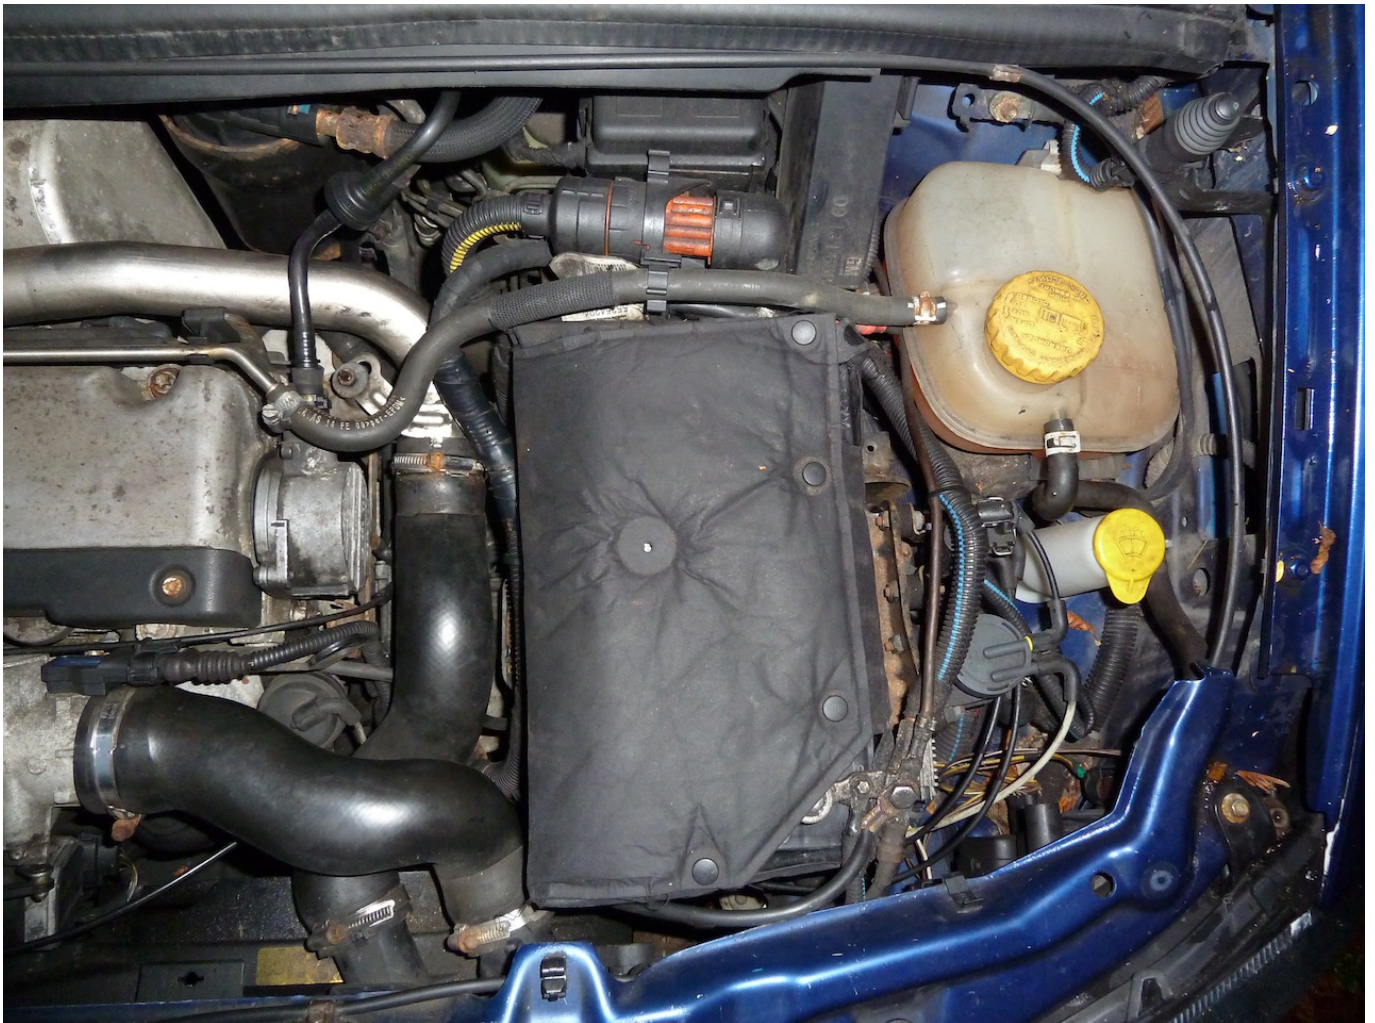
No way in? With many modern cars it's almost impossible to reach the securing clamp, when the time comes to fit a new battery.

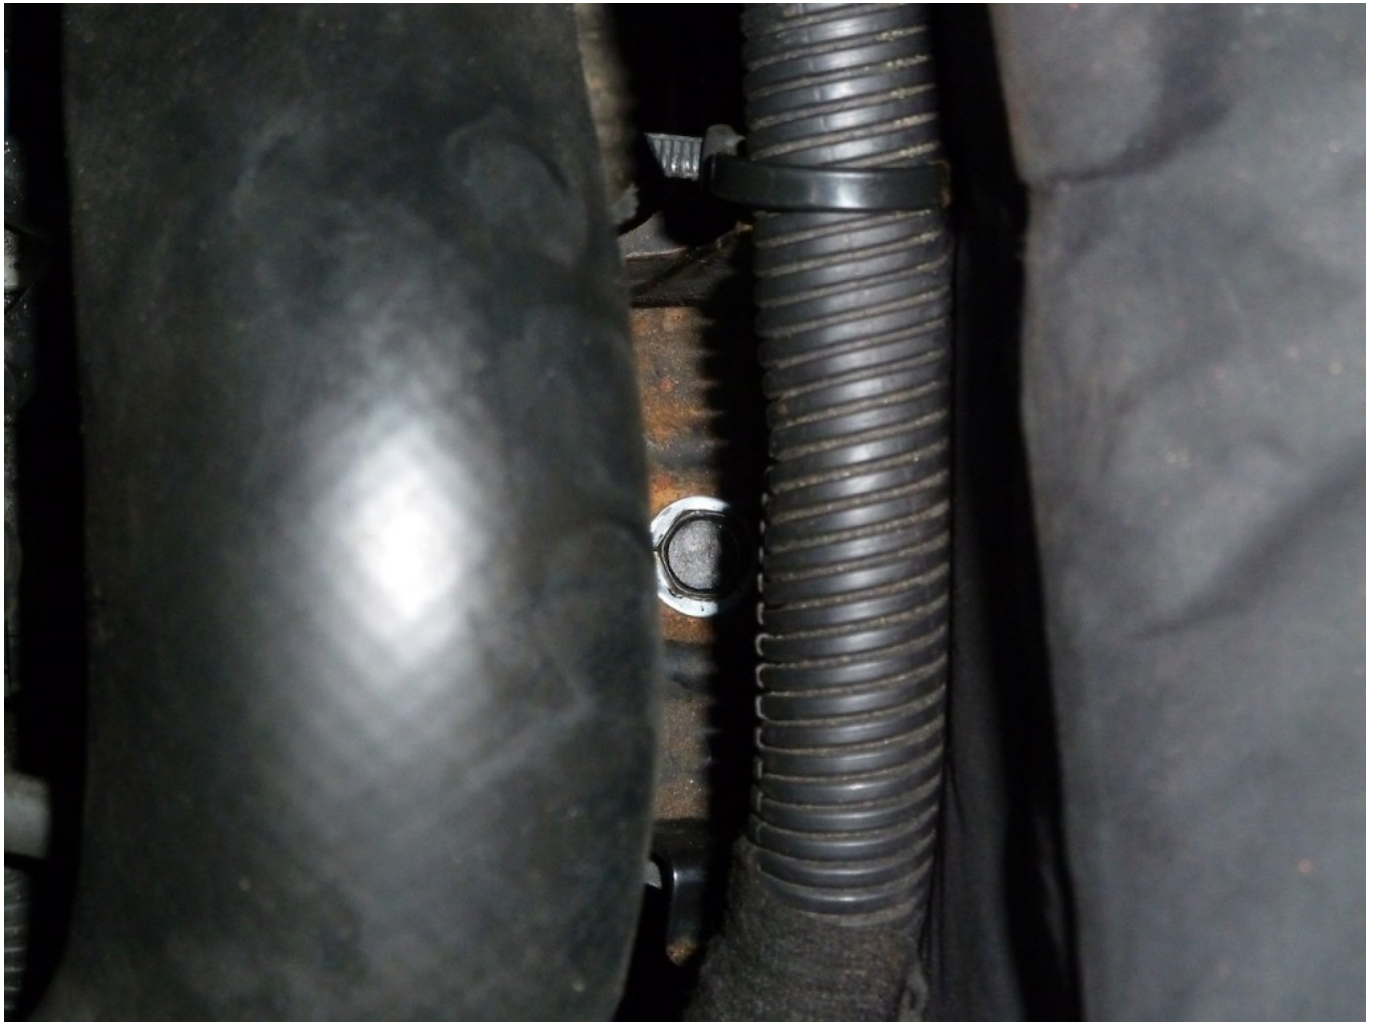
It took one of our mechanics two hours to change the battery. Why? Well when the engine bay was designed, instead of situating the battery's securing clamp bolt in an accessible

position (which would have been quite possible), it was buried in the depths of the engine compartment, amidst a maze of hoses and electrical wiring. Indeed it was almost impossible to see, let alone reach.

Spot the bolt for the clamp securing this battery... It's only just visible, let alone reachable, even after moving hoses, wiring, etc!

We found a new metric bolt, of the same thread dimensions but a little longer than the original (to make it a bit easier to install) and then attempted to fit this, together with new lock and plain washers.

This took a very long time, even after we had moved cables and hoses (such operations also being fraught with potential problems, especially as a vehicle ages and rubber/plastic components can become brittle).

Eventually we 'won' and the battery was installed, complete with its new bolt - but what a performance for a job that should have been quick and easy... How much easier it would have been if the clamp had been mounted in a slightly different position, where it could more easily have been reached.
