**WHEELS-ALIVE!**

## Kim's (Classic) Tips – Check your S.U. petrol pump for leaks

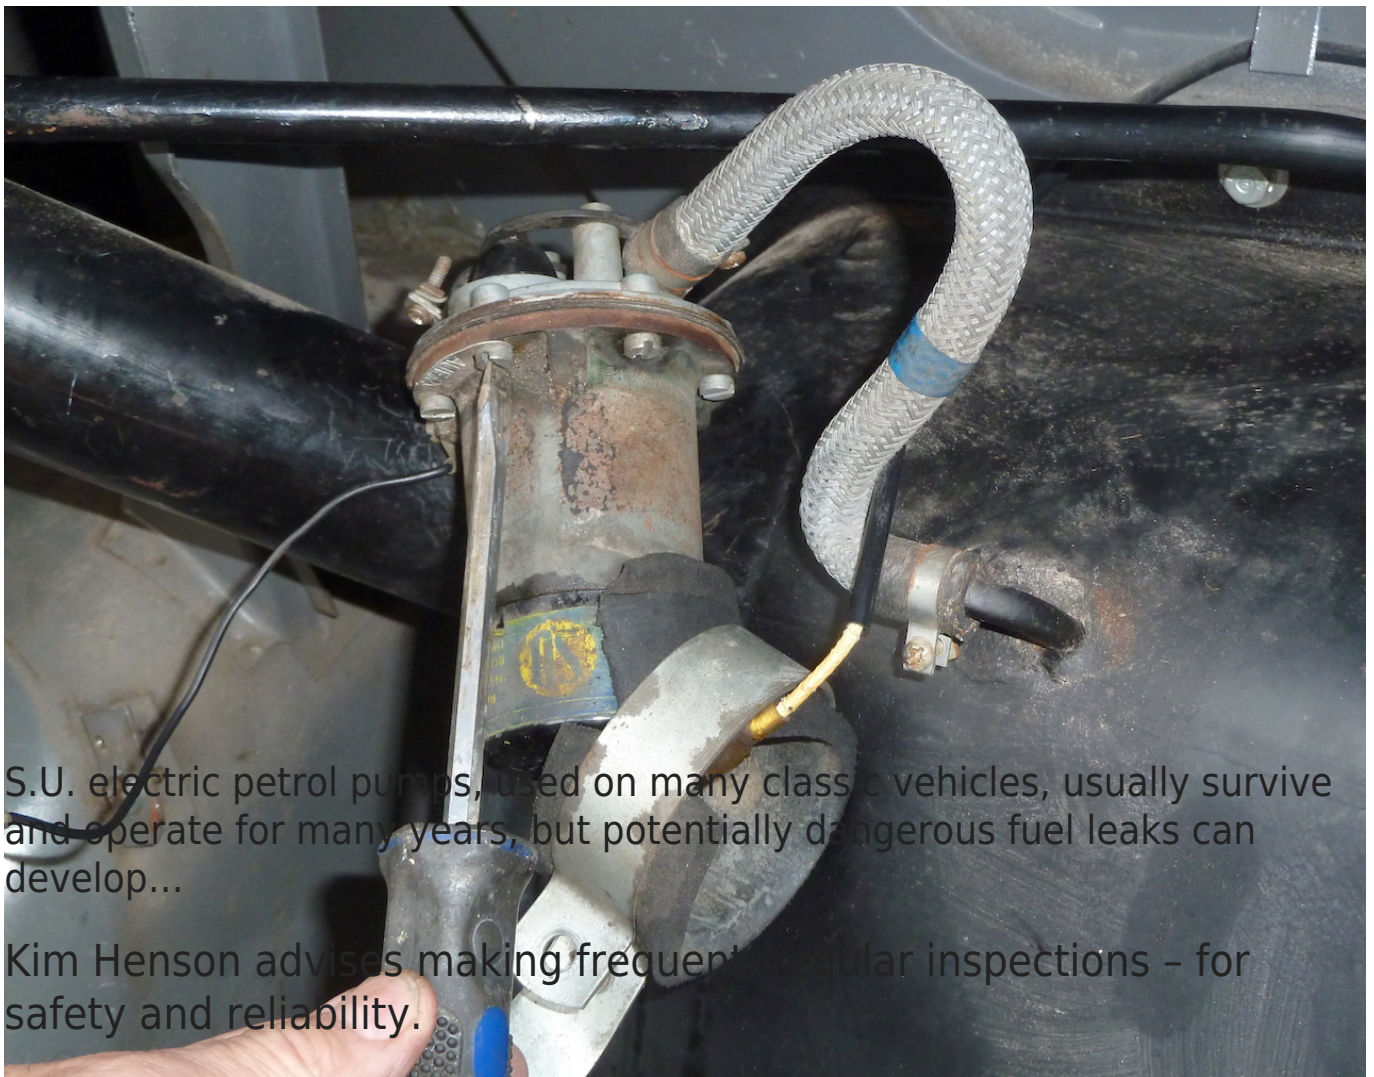
S.U. electric petrol pumps, used on many classic vehicles, usually survive and operate for many years, but potentially dangerous fuel leaks can develop...

Back to the S.U. fuel pump... Regardless of ethanol, in time, leaks can occur from the hoses and their unions at the pump, and these are usually easy to fix. However, in addition, the ring of securing screws situated around the pump body of a typical S.U. pump, and holding the two main sections of it together, can loosen a little in time, resulting in fuel weeping in quantity. I have never seen this written about, but it can and does happen.
