SERIOUS DANGER!!! Zafira rust nightmare revealed by our Grumpy Old Mechanic!

Published: December 6, 2017

Last week a very tidy-looking first generation ('A' Series) Vauxhall Zafira 2.0 DTi dating from late 2003 was brought in to our establishment to have the transmission oil changed, and for one or two other minor jobs.

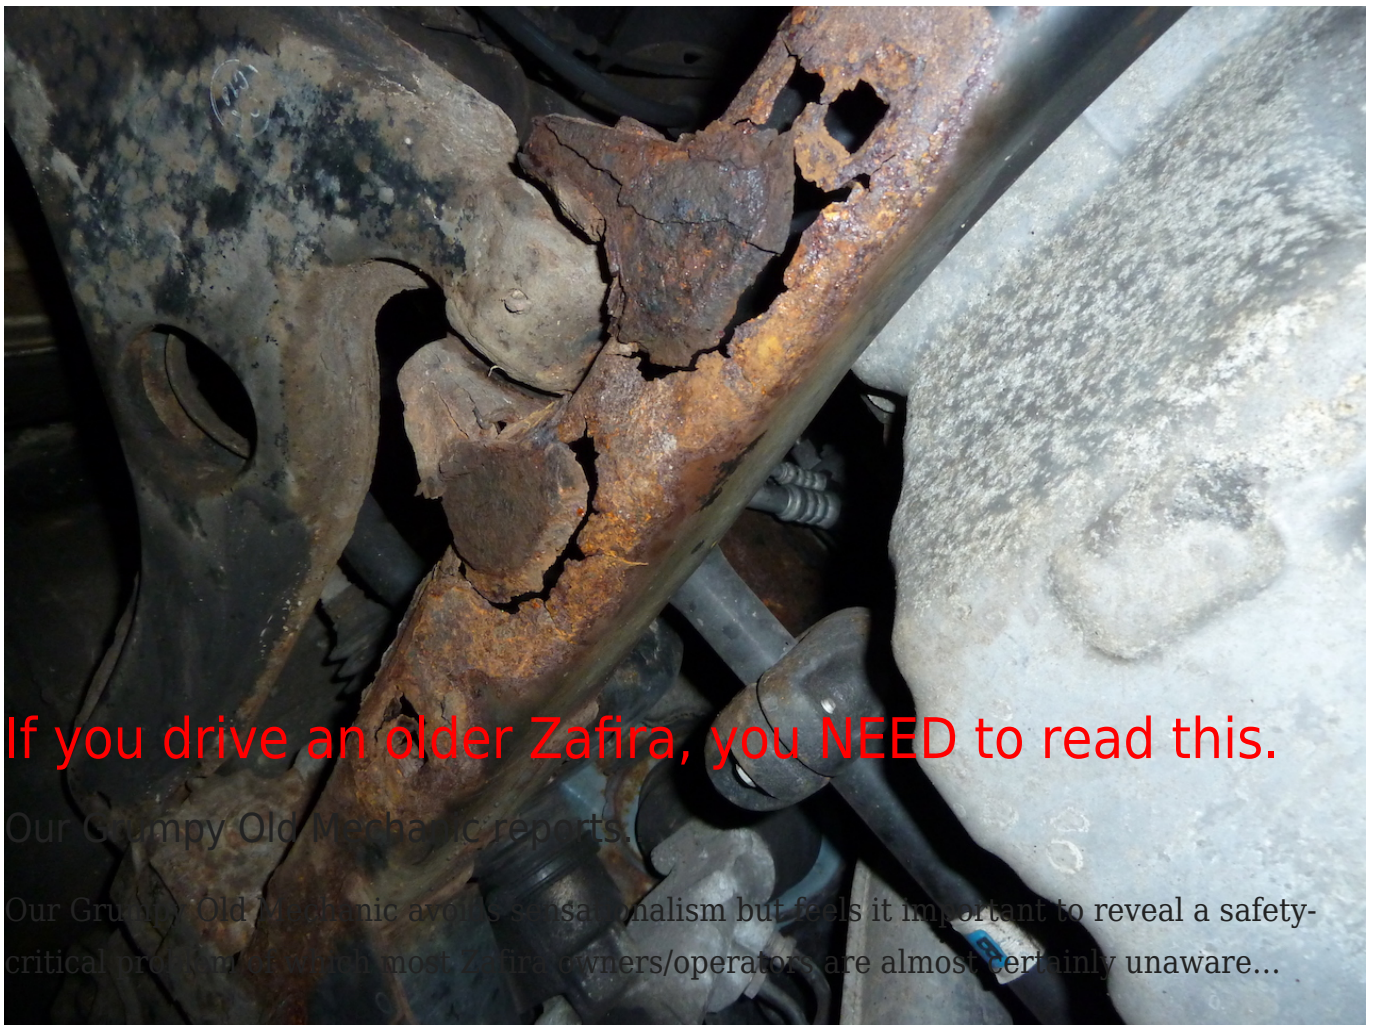
However... When we removed the protective undershield from beneath the front of the car, in order to reach the transmission oil drain point, we were truly shocked to discover that the front sub-frame assembly, on which the front suspension arms are mounted, had disintegrated almost to the point of collapse.

It appeared that the undershield had never previously been removed from the vehicle, or at least not for a very long time. In normal maintenance this isn't necessary (for example to carry out engine oil and filter changes), and during routine maintenance and MoT tests the corrosion damage would not have been evident. In any case MoT testers are not permitted to dismantle components nor remove an undershield like this (which, incidentally, takes approximately 20 to 30 minutes to unfasten and lower).

The undershield covers the whole of the underside of the front of the vehicle, so that the sub-frame is completely invisible. The shield also incorporates a felt-like insulating material which, when the shield is in place, is necessarily held against the underside of the sub-frame side members. Therefore, when this material gets wet in adverse weather conditions, it can't help but hold the moisture (plus road salt often found in this vicinity) against the sub-frame - on this car the rust marks from the rotten sub-frame were clearly visible on the upper side of the undershield.

steel – this probably explains why the bodywork on these cars usually looks very sound. However, the sub-frames are definitely NOT galvanised, with the result that once the paint coating is breached, structural disintegration of the mild steel is inevitable.

In fact the state of the sub-frame was so dire that in my opinion hitting a pothole, or even a minor road surface imperfection, could have resulted in sub-frame/suspension collapse, with consequences that could have been at the very least, extremely serious, if not fatal...

In this case the owner was keen to keep the car, so a new front sub-frame (costing nearly £400 but still made from mild steel!) was bought from Vauxhall and then comprehensively treated with anti-rust paint and wax protection, before we installed it.

We also made a point of removing, by cutting away with a craft knife, the edges of the undershield so that the sub-frame is now visible for inspection from below, and open to the air, to prevent moisture being held against the underside of the sub-frame. In addition the sub-frame can now more easily be re-treated with anti-rust products, and on a regular/frequent basis.

IF YOU OWN A ZAFIRA MORE THAN JUST A FEW YEARS OLD I URGE YOU TO REMOVE THE FRONT UNDERSHIELD (OR GET YOUR MECHANIC/GARAGE TO DO IT FOR YOU) SO THAT THE STATE OF THE SUB-FRAME CAN BE ESTABLISHED. YOU COULD BE DRIVING A POTENTIAL DEATH TRAP YET BE UNAWARE OF IT... YES, THIS IS THAT SERIOUS.
