Sunbeam 1000hp record breaker restoration continues at The National Motor Museum

National Motor Museum engineers piece together newly restored parts, while continuing the engine rebuild of Sunbeam 1,000hp for the 100th anniversary of its record-breaking run in 2027.

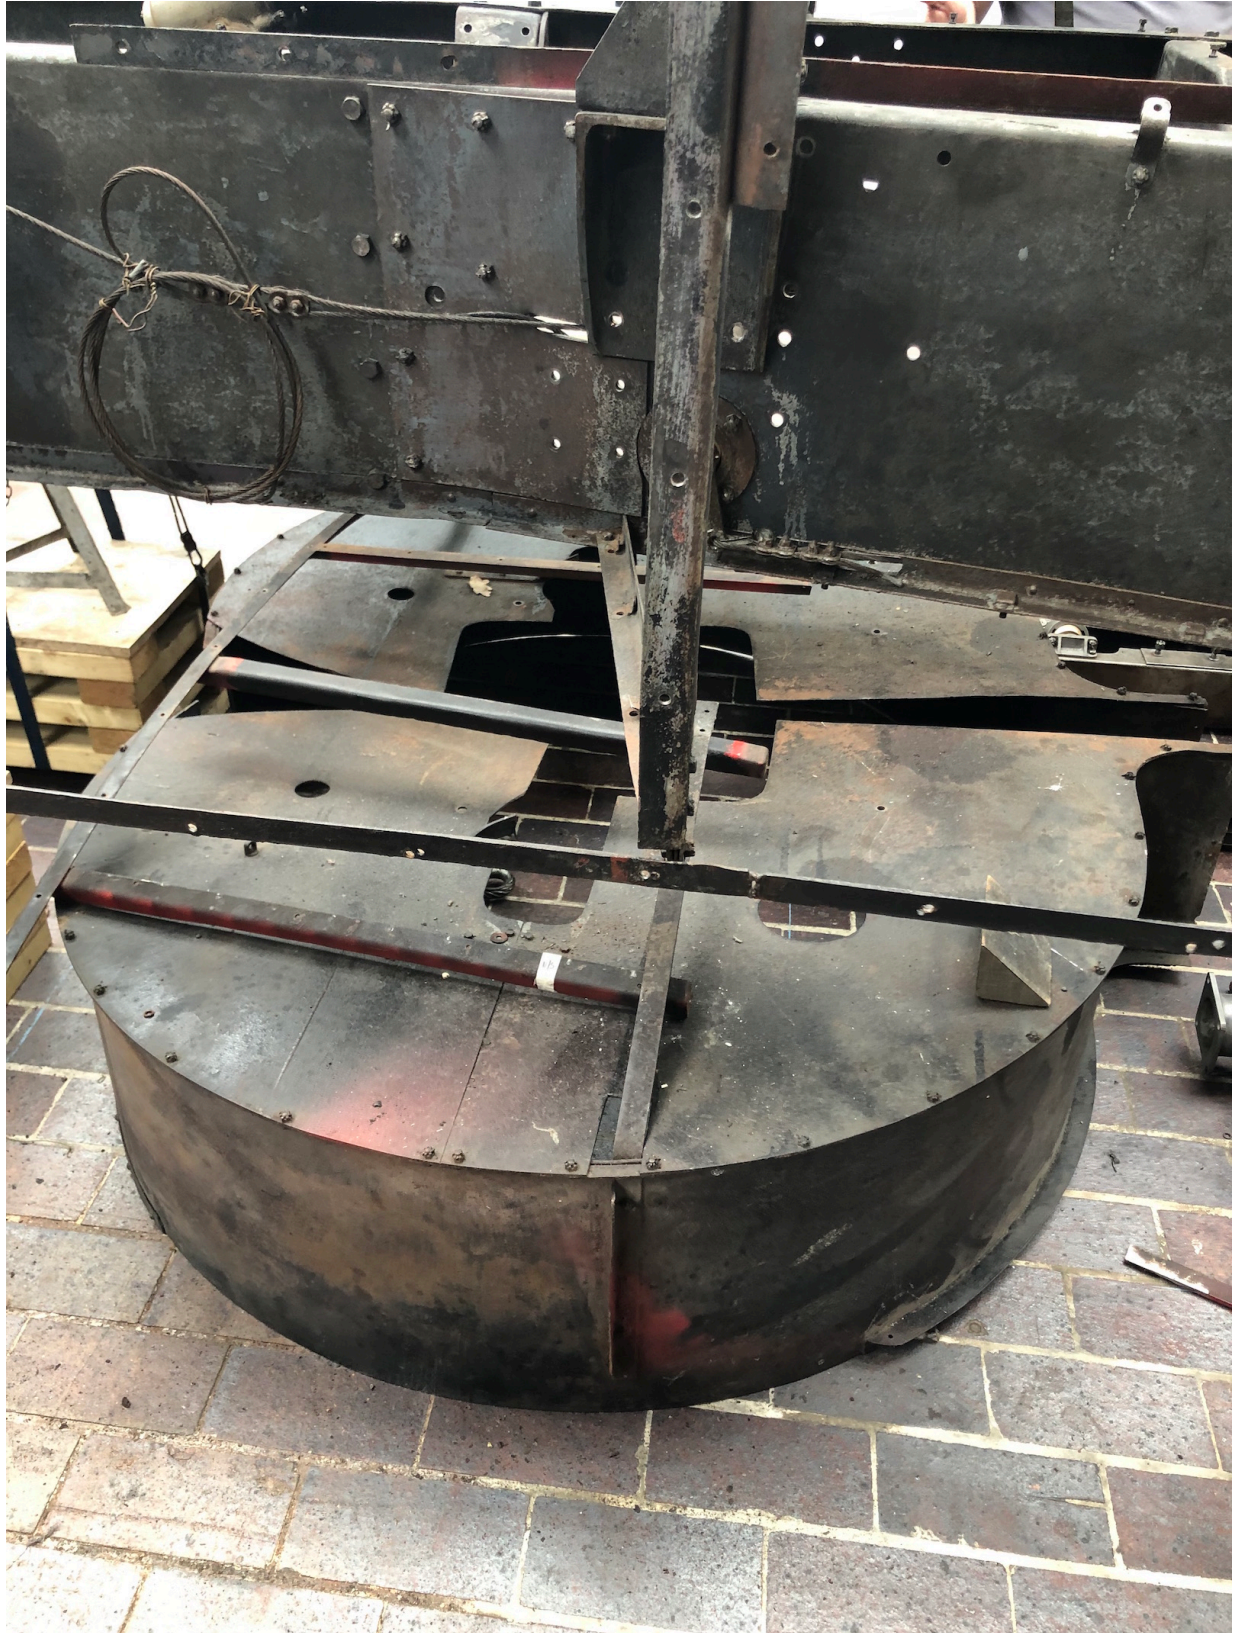
Their answer was to protect Sir Henry with armour plating around the wheel arches, which would also contain any shredded rubber if tyres burst.

vided protection.

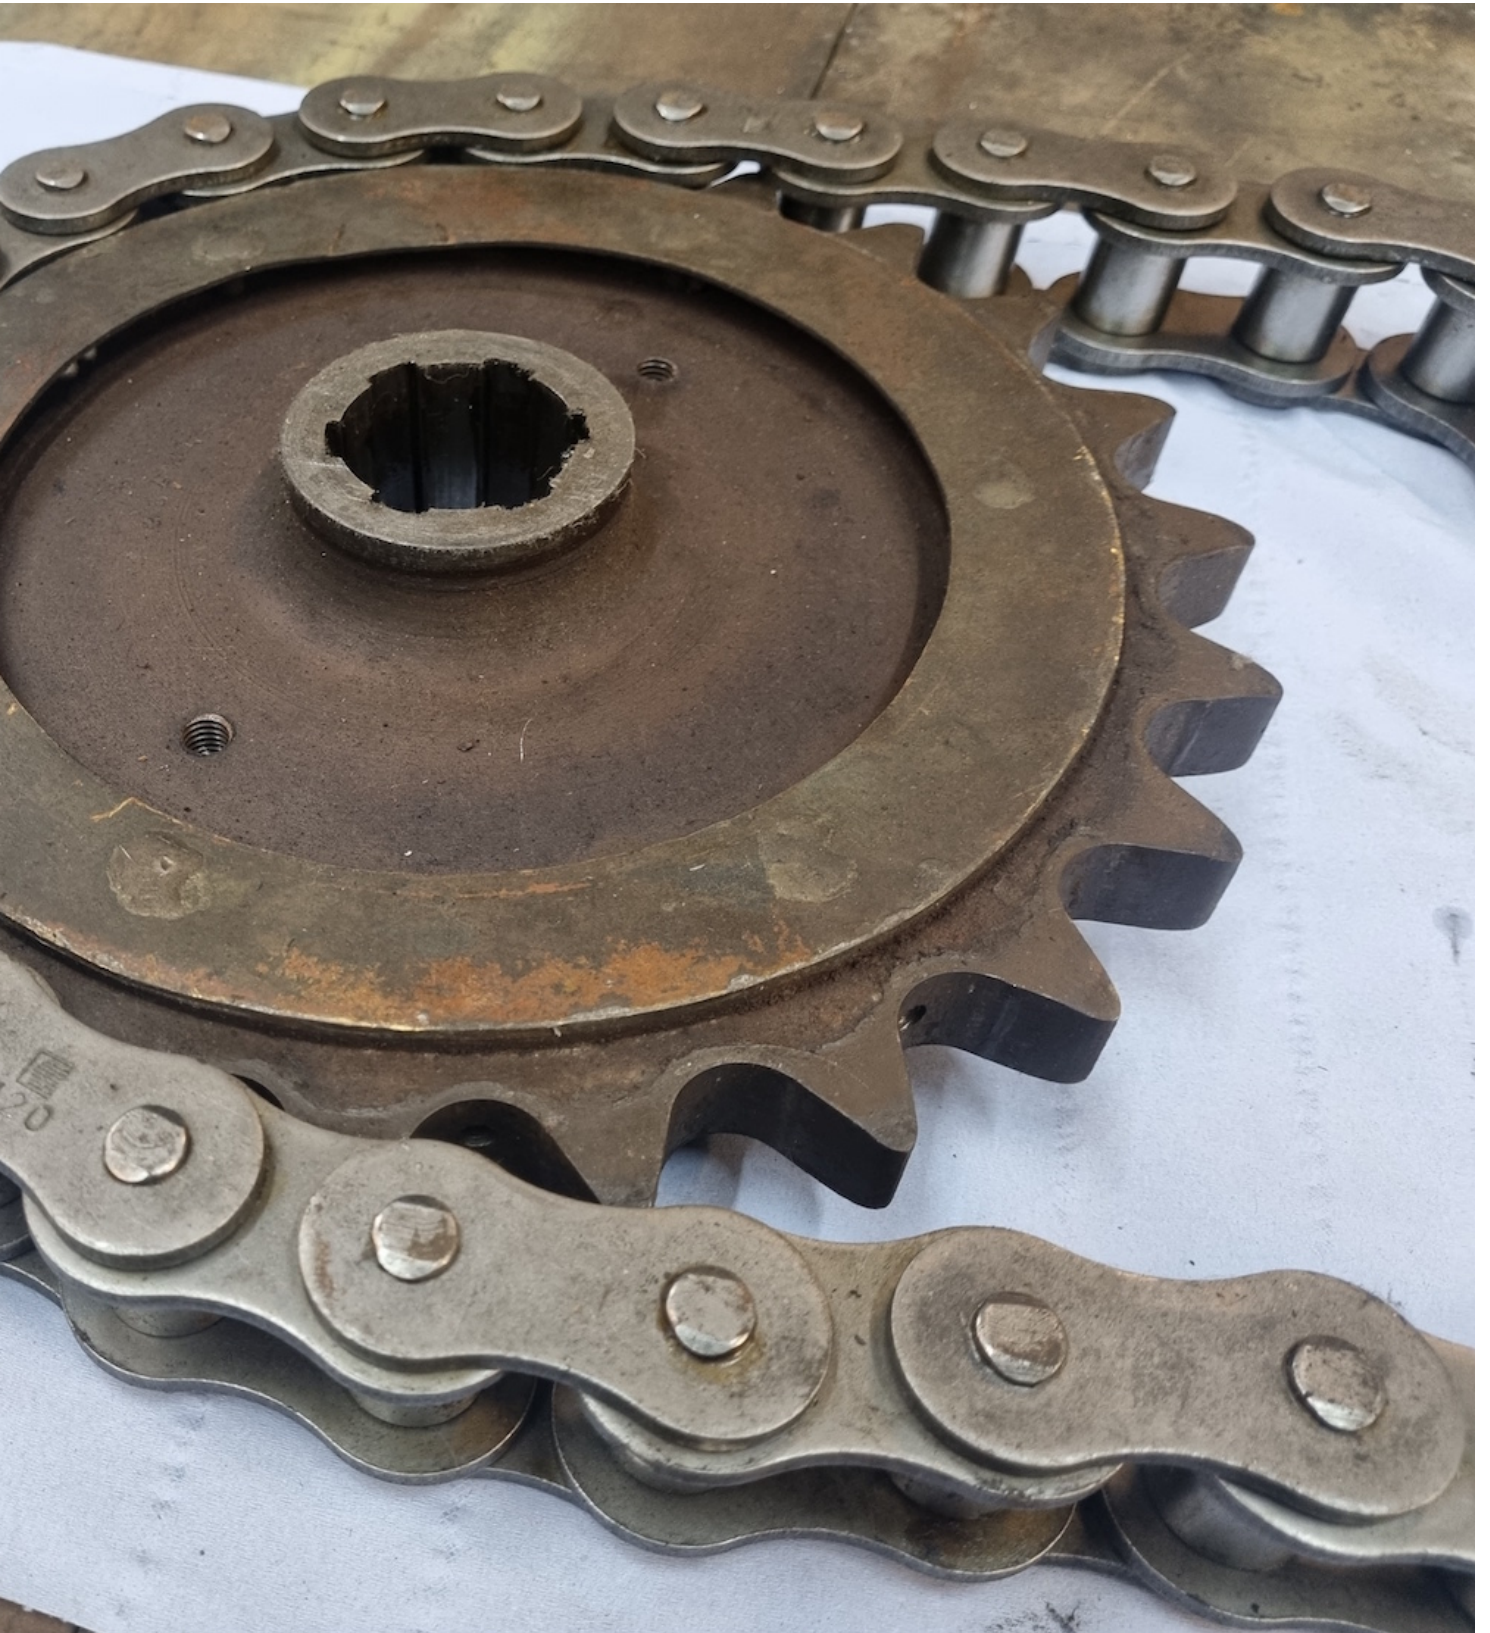
factory testing have had to be replaced.

New replacement chains have also had to be sourced, as chains with the width size of the originals no longer exist.

Specialist cleaning of the brake drums by LaserTec experts exposed a crack in one of the rear brake drums.

National Motor Museum Senior Engineer Ian Stanfield said: “We were hoping to repair the crack but it wouldn’t weld. It’s an expense we hadn’t wanted but we have needed to go to Bridport Foundry for a pattern to produce a new drum.”

Aluminium brake shoes also distorted and started to melt during the record-breaking run. At Daytona, the original engineering team replaced them with bronze and during the restoration, their oil-contaminated linings have been replaced.

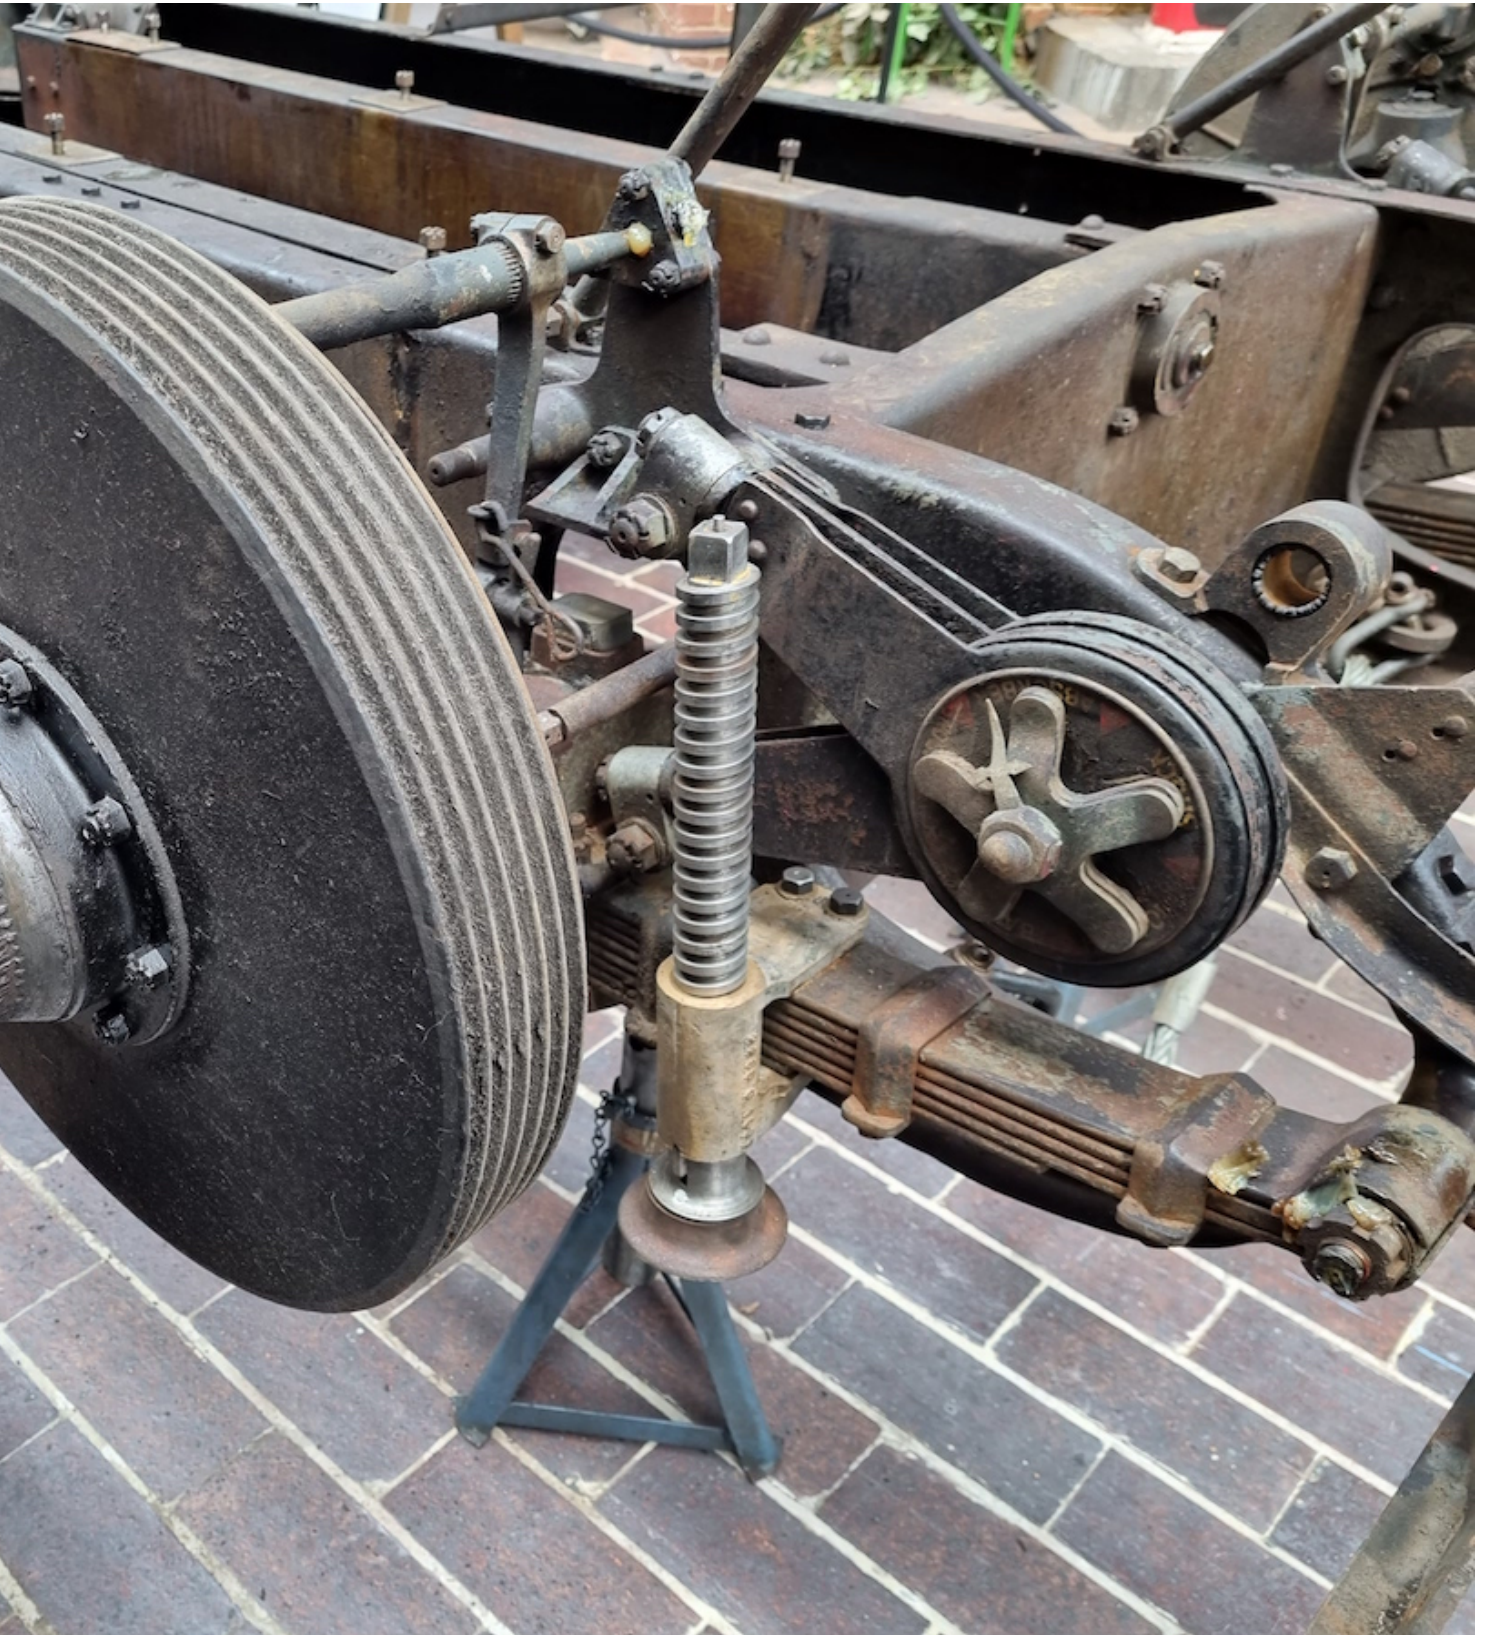
Motor Museum shows workings of Sunbeam 1000hp wheels and jacks.

Unique tyres had been developed by Dunlop to withstand the record-breaking attempt of 200 mph at Daytona on March 29 in 1927. Each tyre was only guaranteed for three-and-a-half minutes and both the wheels and tyres had to be changed after each run, using four handy jacks bolted to each corner of the car.

At some time in the landmark car's history, before arriving at Beaulieu, its wheels had been modified to fit a 600 x 23 tyre size but even that size is now unavailable. So engineers have retained the only original part of the wheels - the hubs - while fitting new rims and spokes to replace the non-original, welded ones which had been added in the 1950s. They have kept to as close to the original wheel sizes as possible, with help to source new tyres from Vintage Tyres at Beaulieu.
