## 'We have ignition' – or do we?

Classic car ignition systems and their ailments – some useful notes to help

## enthusiasts

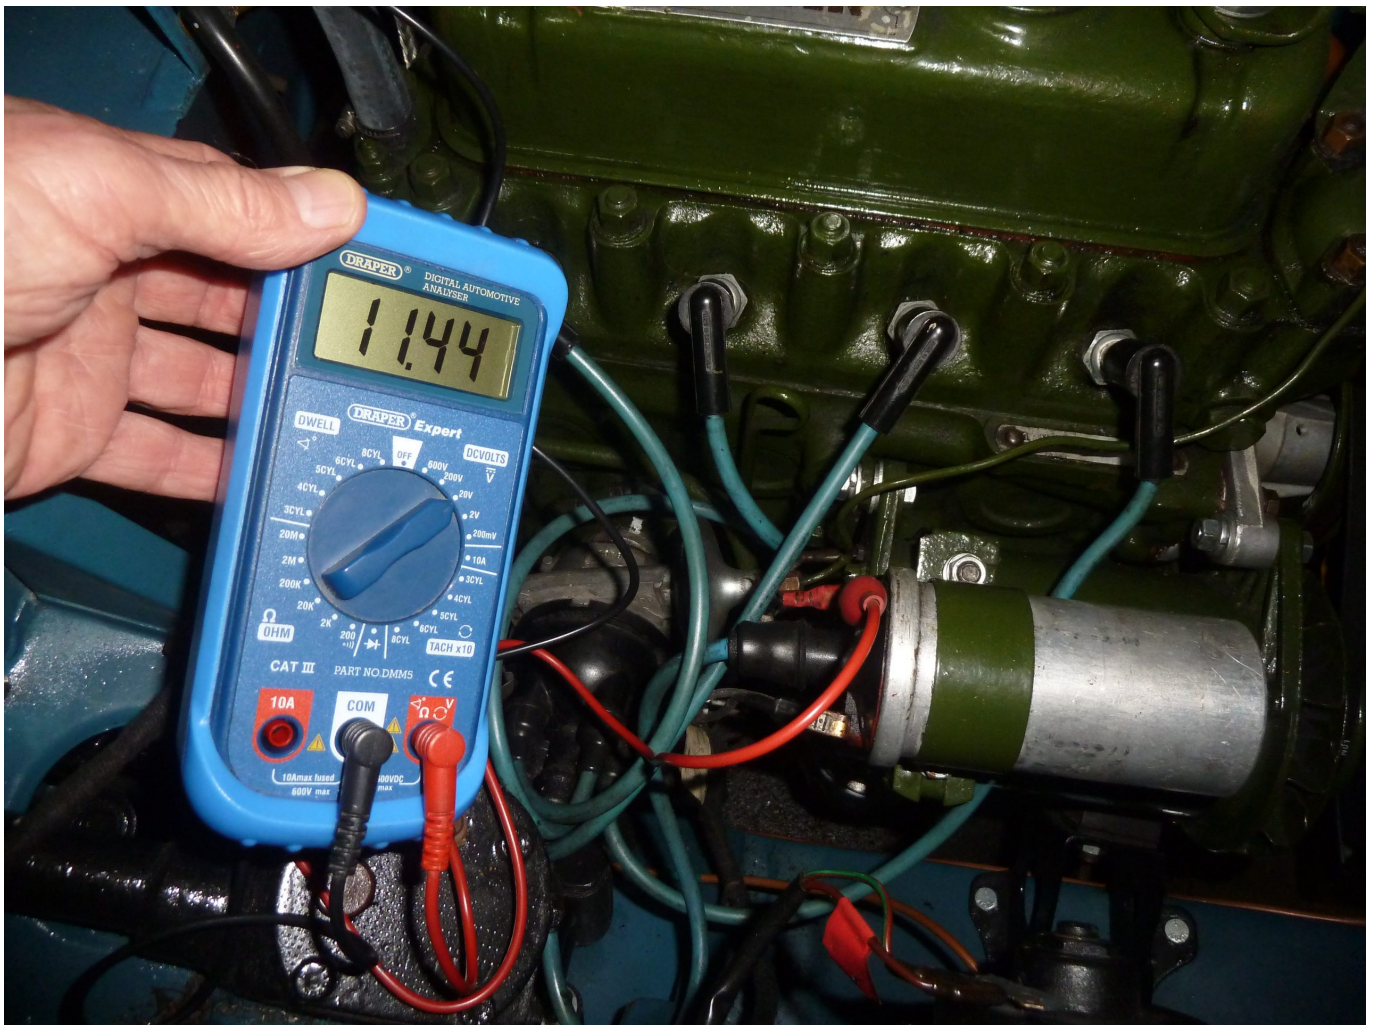
On a car with a traditional 12 volt ignition system, you should be seeing around 12 volts at the ignition coil; starting and running problems arise if the voltage is much lower... (please see text).

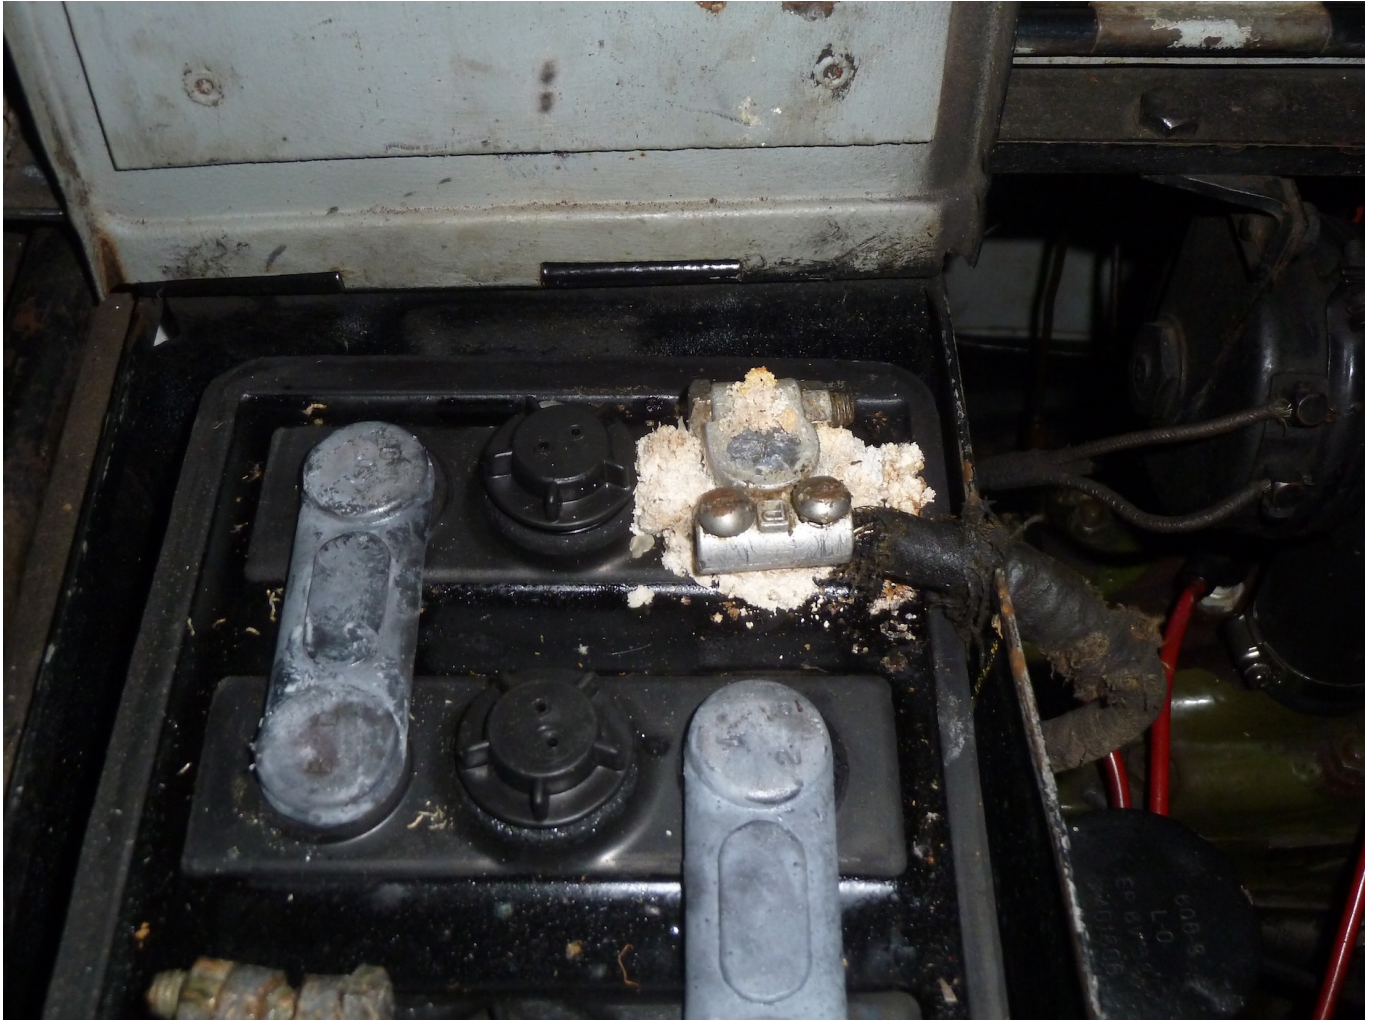
A battery terminal looking like this is very bad news. At the outset dismantle the joint, clean and re-assemble. This advice applies to all electrical connections in the system.

It is worth saying that in any electrical assessment on an older vehicle, it is wise to start with the car's battery, ensuring that it is in good condition (have it tested if necessary) and with clean and secure connections. If in any doubt, remove the terminals from the battery, thoroughly clean the connections (wear protective goggles and gloves) and re-assemble, protecting the terminals from future moisture accumulation/attack by applying petroleum jelly or silicone grease.

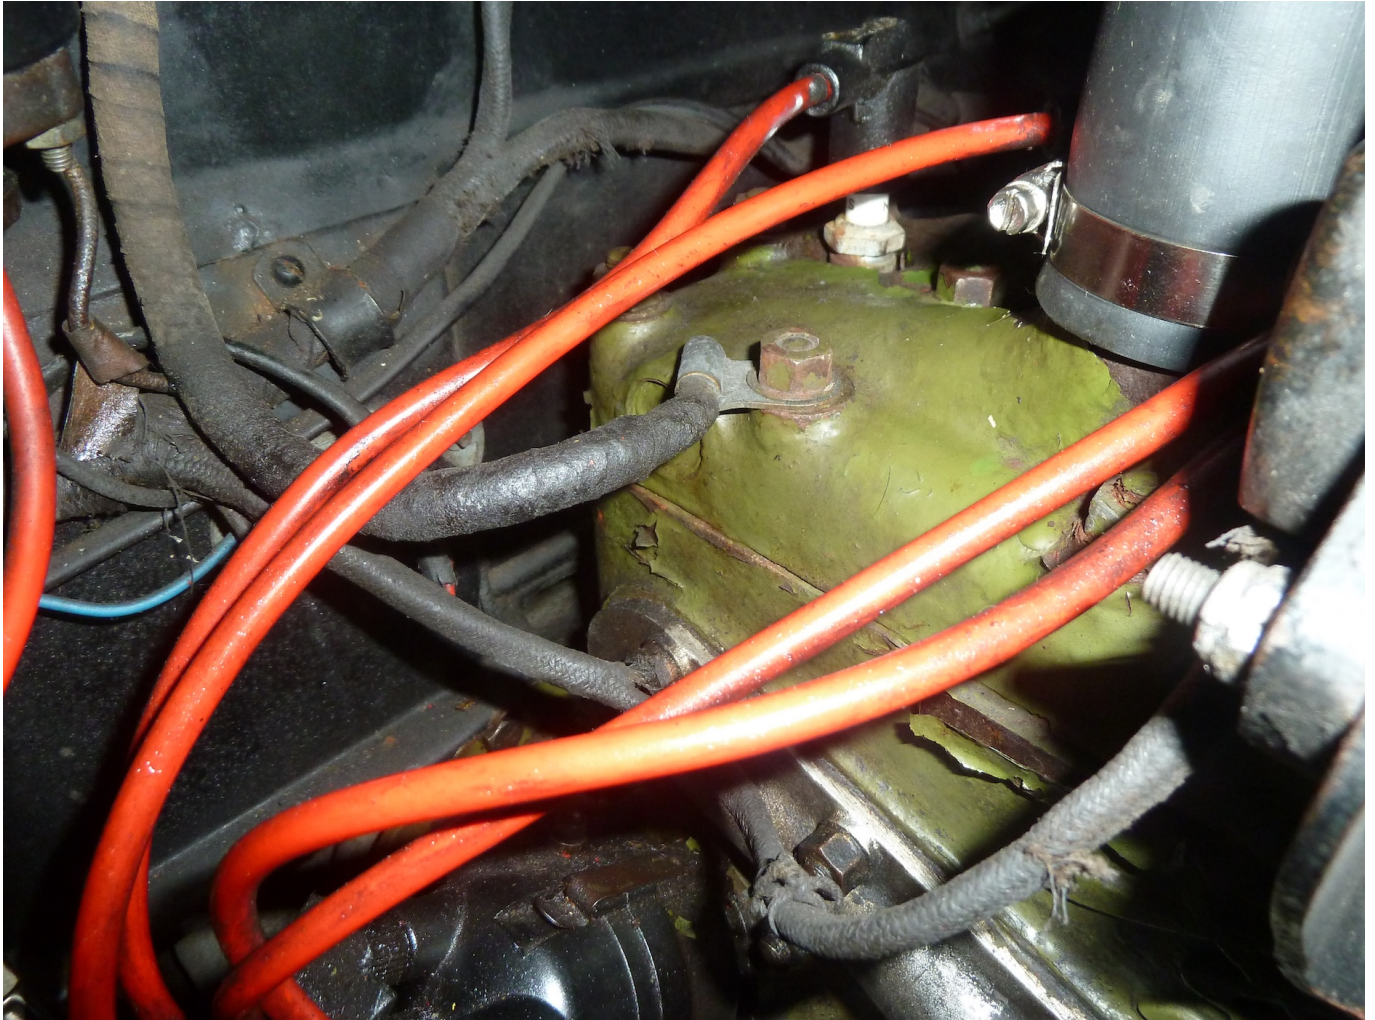
Earth connections to the cylinder block or head (as visible here) need to be clean and tightly attached.

Earth connections are vitally important throughout the system too; ensure that all are clean and secure.

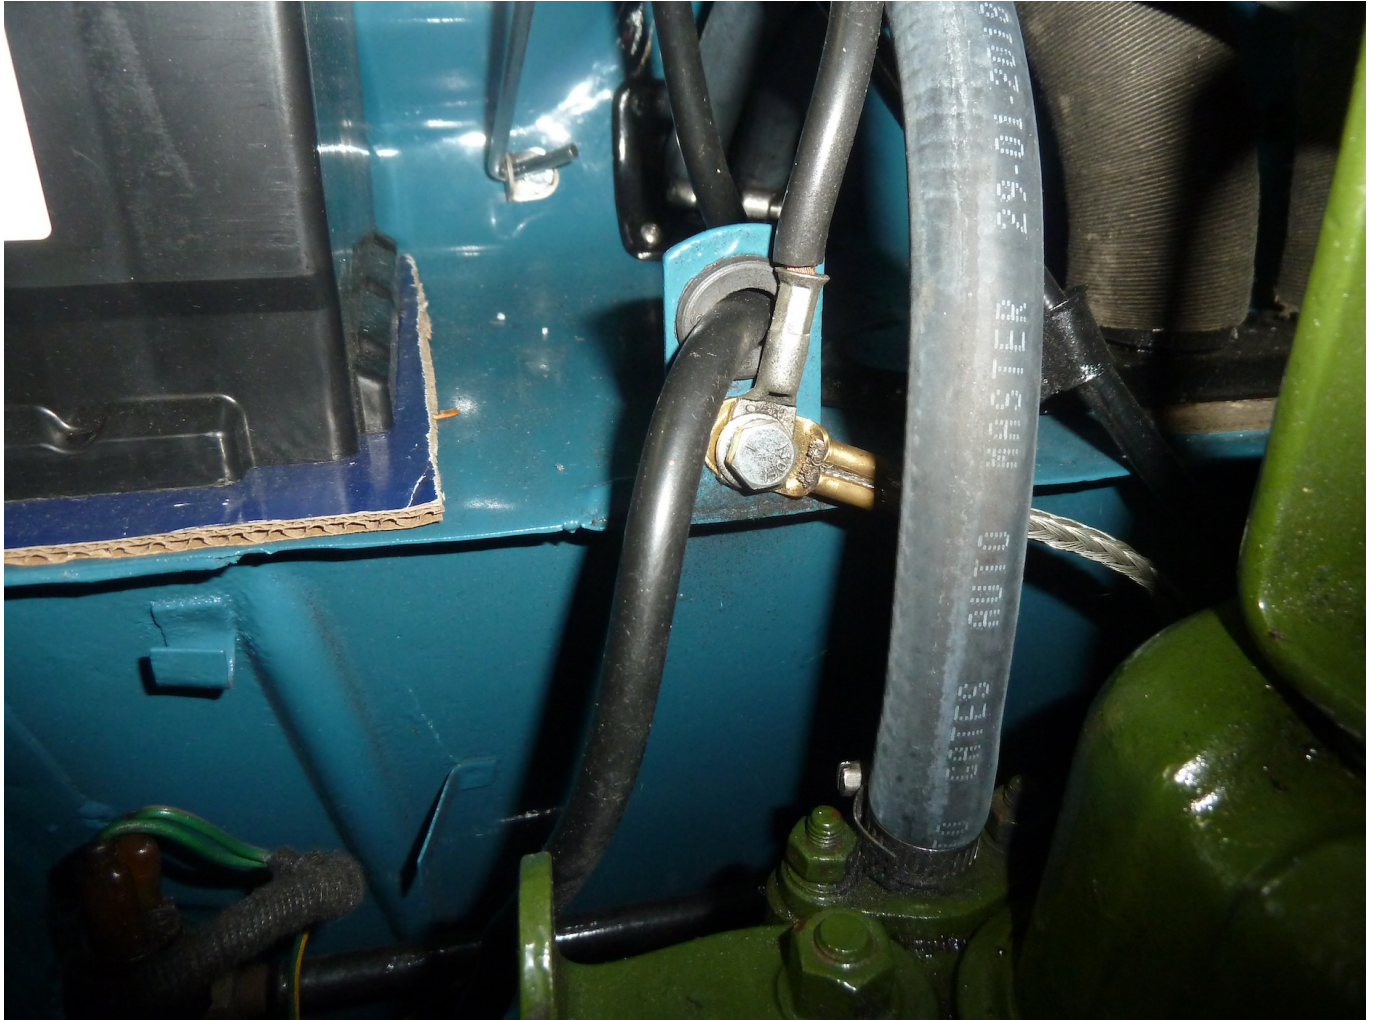
Some classics have joints in the main earth straps, connected at the bulkhead or 'chassis';  
check closely!

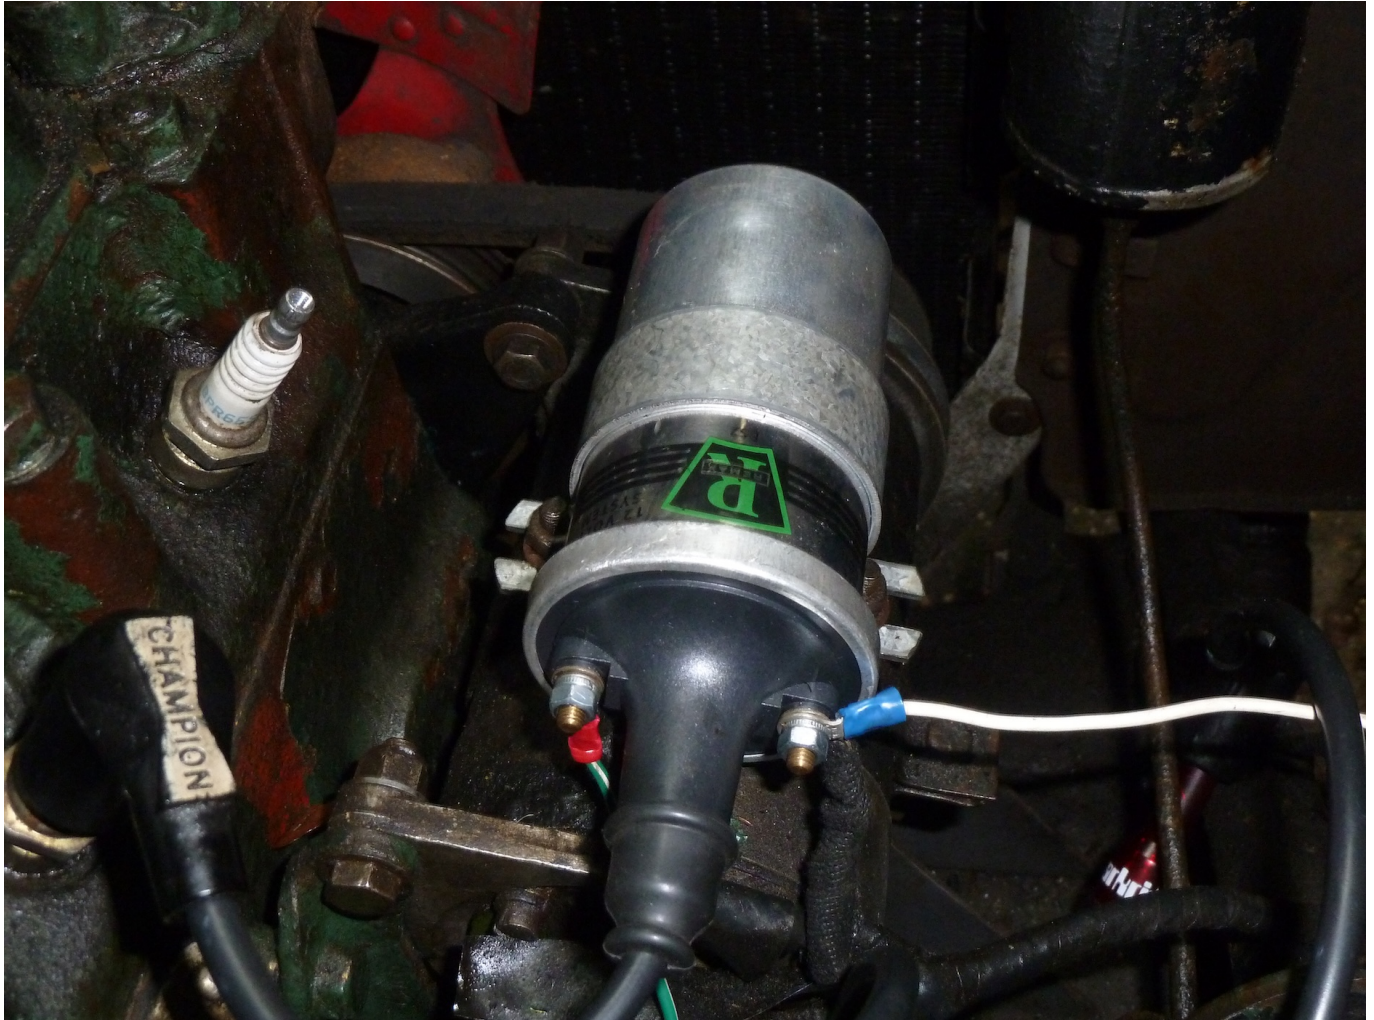
Cable connections at the ignition coil **MUST** be sound; make sure that they are clean and that the securing nuts are tight. (Note that on this car the original cables have been changed using non-original colour coding; not really a good idea!).

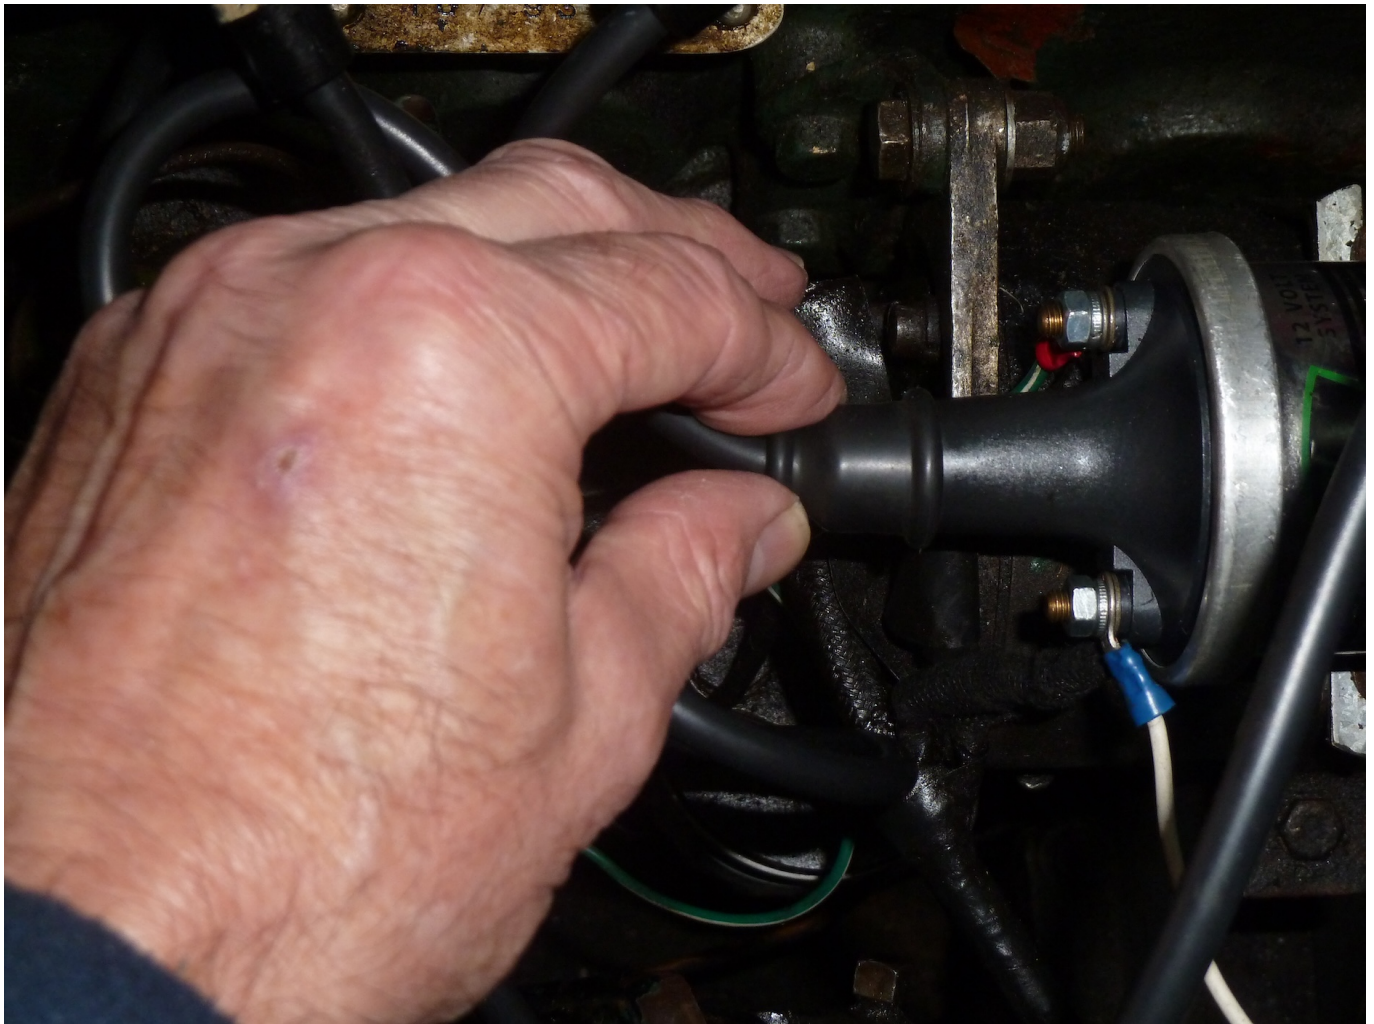
On this car it was found that the high tension 'king' lead at the centre of the ignition coil was only 'finger-tight', resulting in intermittent operation.

Don't overlook the high tension circuitry; poor starting and 'intermittent' running could be due to connections not being fully tight, and/or to breakdown of (for example) 'carbon string' type high tension leads connected to the spark plugs.

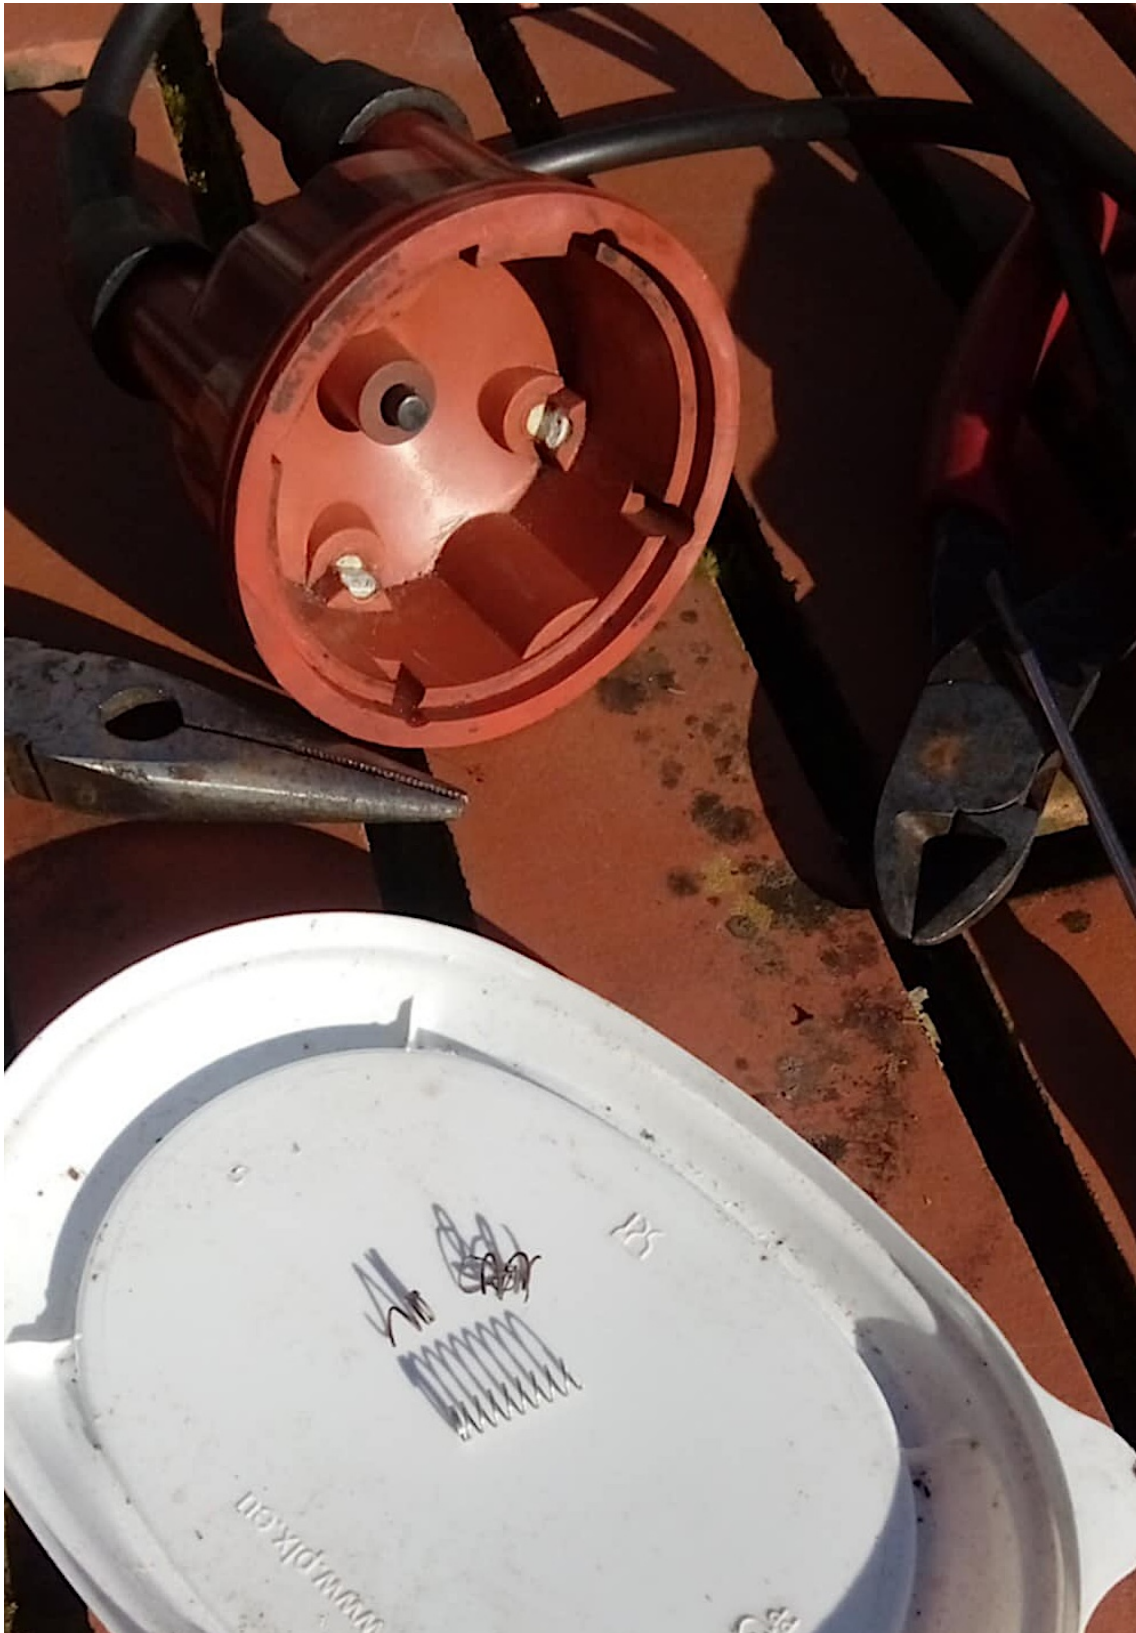
Disintegration of the coil spring above the carbon brush in the distributor cap; check this aspect! Photograph © Sheridan Risby.

Not helping matters when I searched on the floor for the carbon brush that had made its escape, the car is parked on bare earth. Eventually I found the brush and discovered that the coil spring holding it in place has rusted away! That's why it dropped out; the remains of the spring can be seen in this photograph, below.

Anyway, I sacrificed a ball point pen for its coil spring of the correct diameter, installed it in the distributor cap (attached to the carbon brush) and hopefully all should now be ok!
