## Assault and Battery? – Grumpy Old Mechanic

Author: Kim Henson

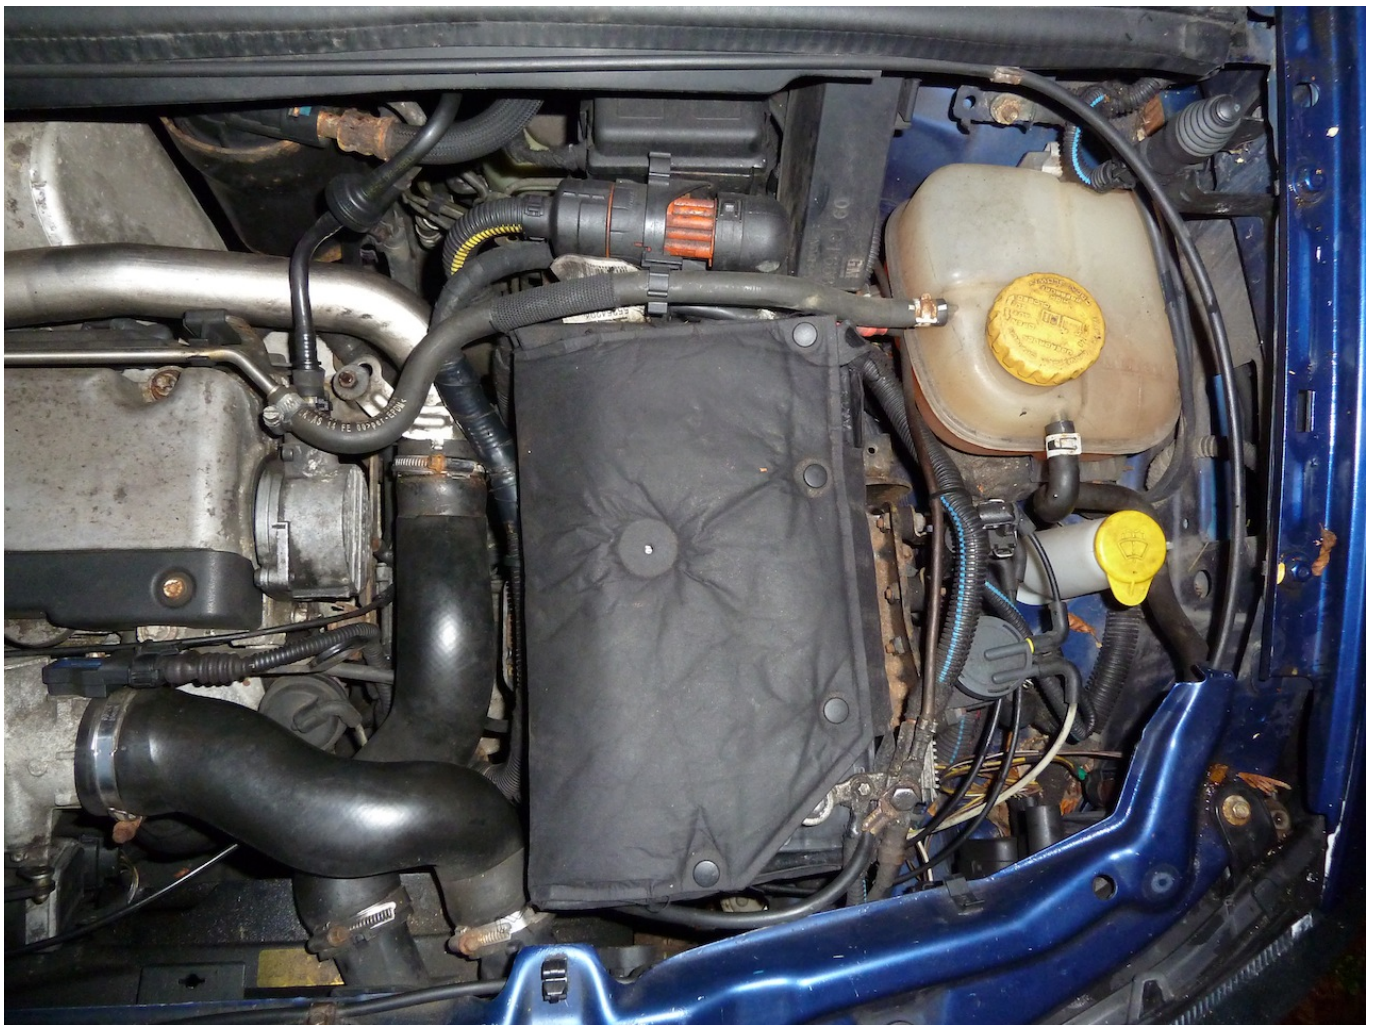
No way in? With many modern cars it's almost impossible to reach the securing clamp, when the time comes to fit a new battery.

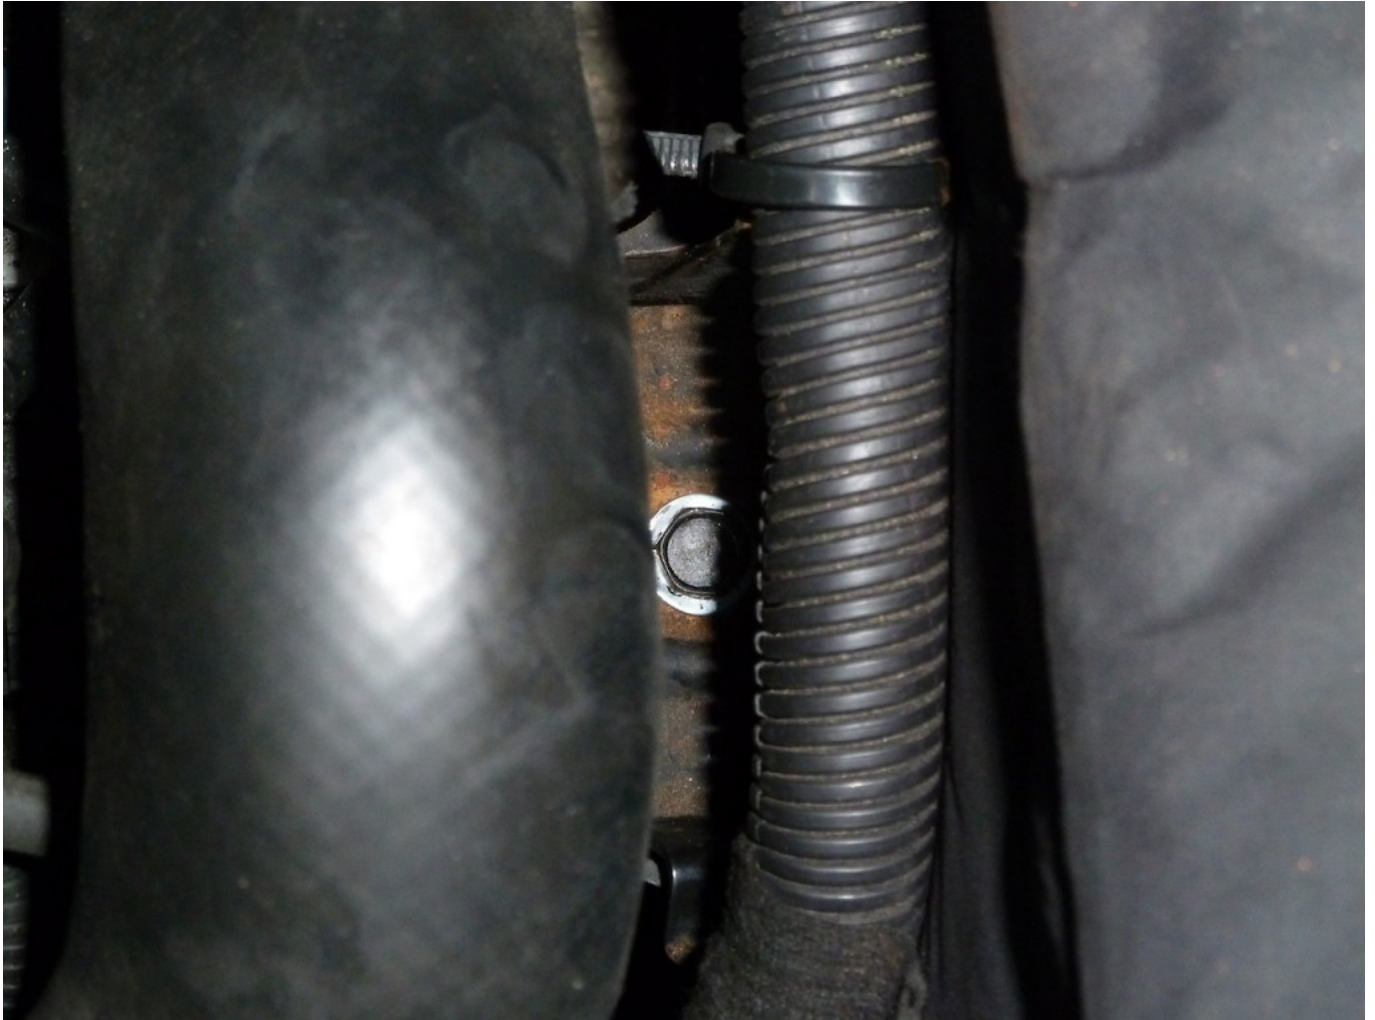
position (which would have been quite possible), it was buried in the depths of the engine compartment, amidst a maze of hoses and electrical wiring. Indeed it was almost impossible to see, let alone reach.

Our chap, who is diligent and knowledgeable, took great care to release and unscrew the bolt so that it would remain within the clamp ready for easy re-assembly. Unfortunately, due to the poor access and the bolt being too short for the job (it was an original bolt that had been in the car from new!), the bolt was disturbed as the battery was lifted out. Said bolt then disappeared into the depths of the engine bay, and, despite the best efforts of three of us, has not been seen since, so tightly packed is the engine within the bay.

Spot the bolt for the clamp securing this battery... It's only just visible, let alone reachable, even after moving hoses, wiring, etc!

We found a new metric bolt, of the same thread dimensions but a little longer than the original (to make it a bit easier to install) and then attempted to fit this, together with new lock and plain washers.

This took a very long time, even after we had moved cables and hoses (such operations also being fraught with potential problems, especially as a vehicle ages and rubber/plastic components can become brittle).

Eventually we 'won' and the battery was installed, complete with its new bolt - but what a performance for a job that should have been quick and easy... How much easier it would have been if the clamp had been mounted in a slightly different position, where it could more easily have been reached.
