Bridgestone DriveGuard 'run flat' tyres available for more vehicles – News and Road Test

Published: June 30, 2017 Author: Robin Roberts

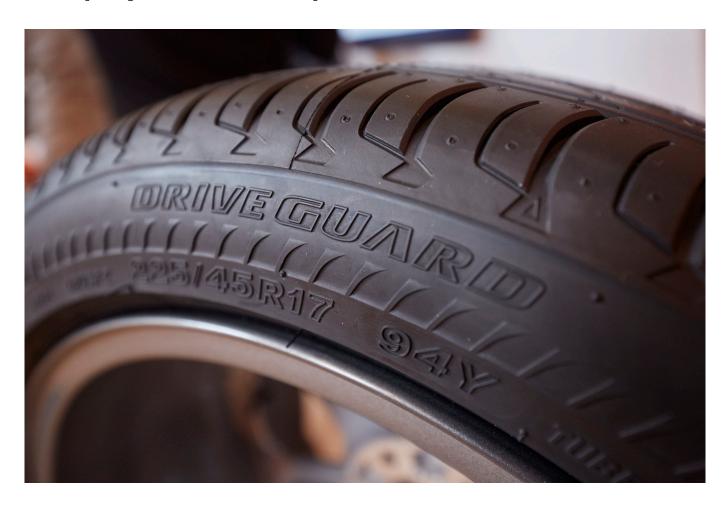
Afterwards a visual inspection of the deflated tyre showed it remained firmly on the rim, which is not always the case with punctures, but there was a telltale greying of the sidewall due to heat build up and which could be felt placing a hand on it.

A deflated left-front tyre puts the greatest strain on a car's handling because in Britain we have clockwise roundabouts. Once deflated the DriveGuard tyre rests on the thicker

sidewalls and the heat build up from driving is dissipated by cooling fins which carry it away as it rotates.
