Flexible Hoses – Check them

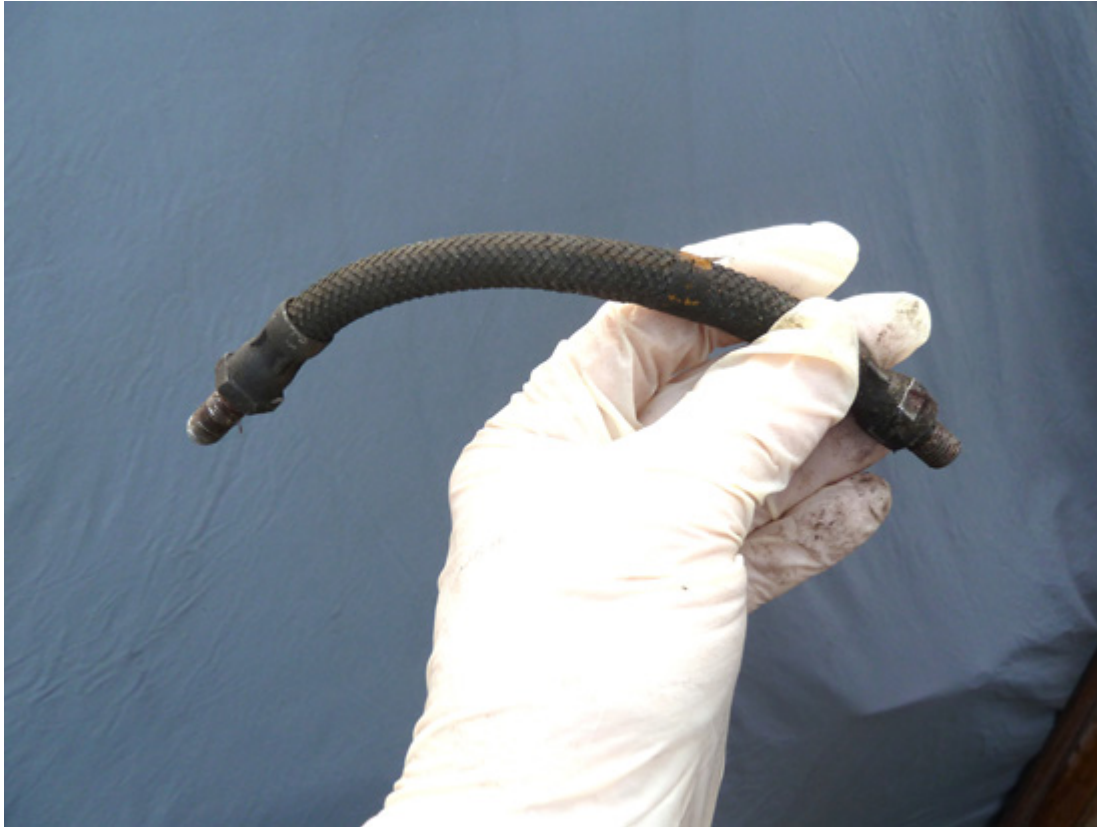
This flexible hose from a hydraulically activated clutch system looked fine from the outside, but was almost completely choked within, due to disintegration of the internal walls. This resulted in severe clutch slip after every gearchange, due to the fluid being unable to move rapidly back through the hose to the master cylinder and its fluid reservoir

However, sometimes troubles can develop unseen within the hoses, notably internal collapse of the hose walls, or internal disintegration. In such cases the hose may look fine from the outside, yet passage of hydraulic fluid through the hose is restricted, so the component to which the hose is connected may not be able to function as designed. Often this takes the form of correct initial operation (for example of the clutch or brakes, as fluid is forced through the restricted section of the hose under heavy pressure applied at the foot pedal), but followed by a 'lazy' return of the fluid to the master cylinder/reservoir. So, for example, brakes may be slow to release, or the clutch may slip. In severe cases, if a brake hose (say) is almost completely obstructed internally, the brakes may pull to one side, giving the impression that the caliper or wheel cylinder piston(s) on one side of the vehicle are seized or otherwise inoperative.
